Installation of Helicoid WRES Epoxy Sleeve[®]

Wellhead Repair

PETRONAS Carigali
(PMA)

Palas-A

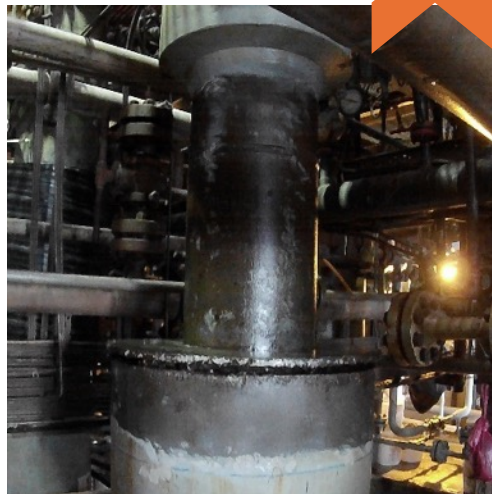
Condition after surface preparation
