## BT-101 Conductor Cement Crack

### Findings (25/2/2026):

## BT-101 Well Diagram

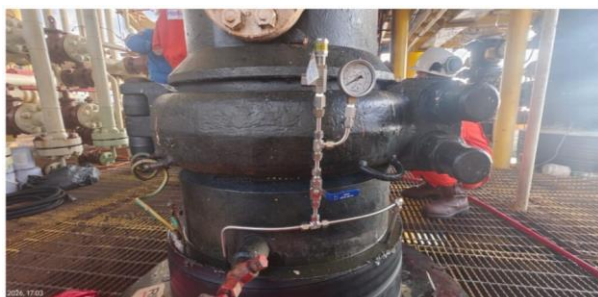
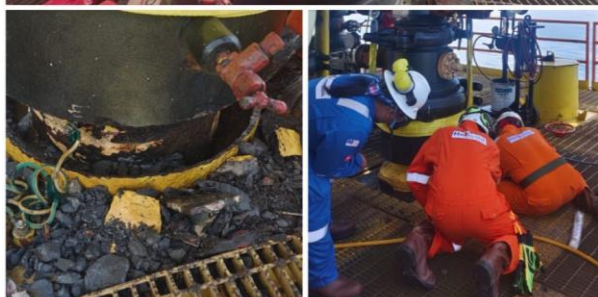
Remediation works 3 – 7 April.
