Case Study

Installation of Helicoid Epoxy Sleeve®

Riser Repair Services

AMPP-05

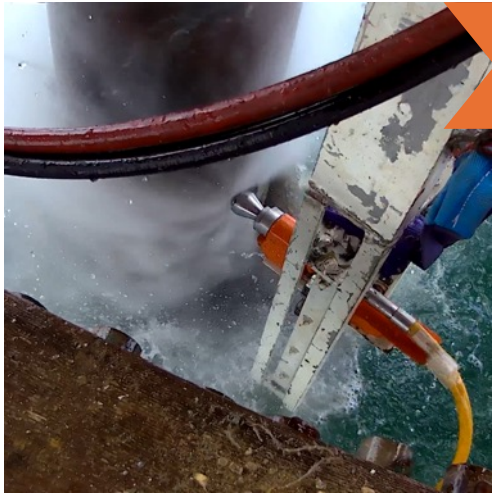
Surface Preparation

- To carry out Surface Preparation via High Pressure Water Jetting to remove the existing coating and marine growth.
- To perform winding installation of HDPE sleeve and Carbon Fibre strip.
- To conduct mixing and injection of epoxy grout for the Helicoid sleeve.

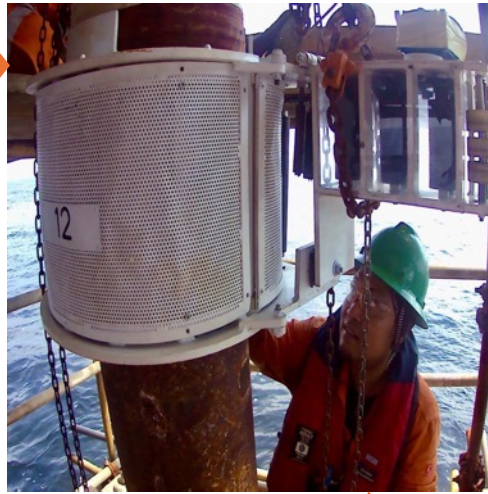
Winding Cage Installation

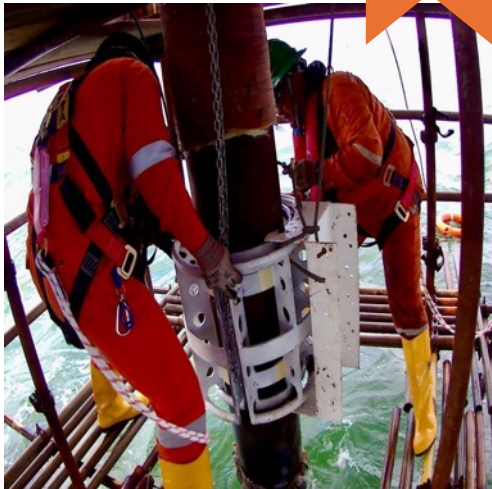
Pipe Bracket Installation

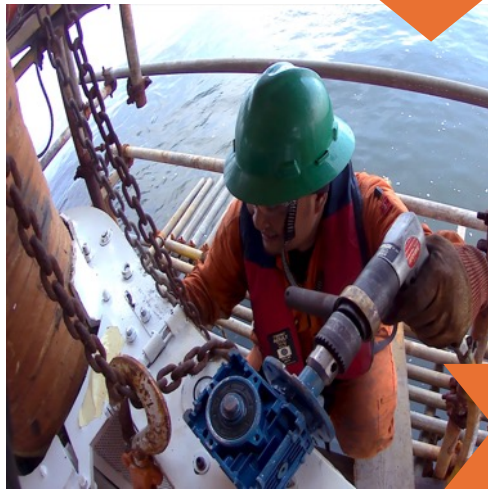
Winding HDPE

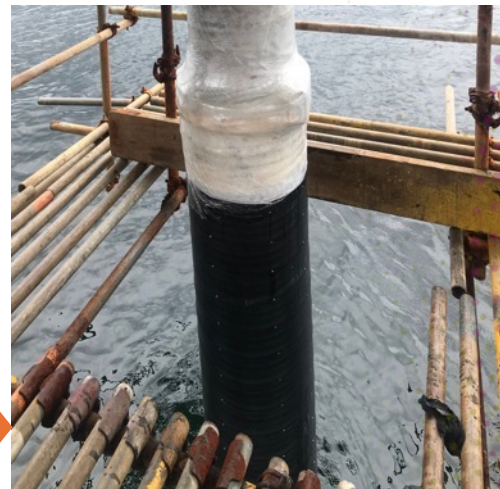
Completed Installation
