Case Study

Installation of Helicoid WRES Epoxy Sleeve[®]

Wellhead Repair
Services

BTJT-A

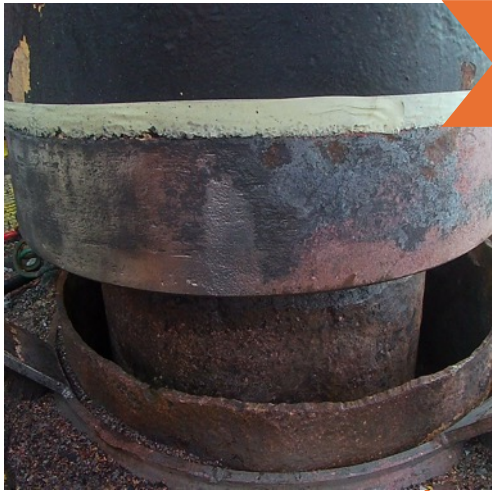
Existing Cement Removal

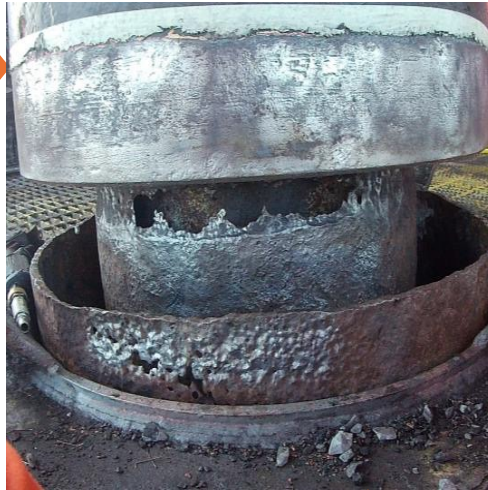
Surface Preparation

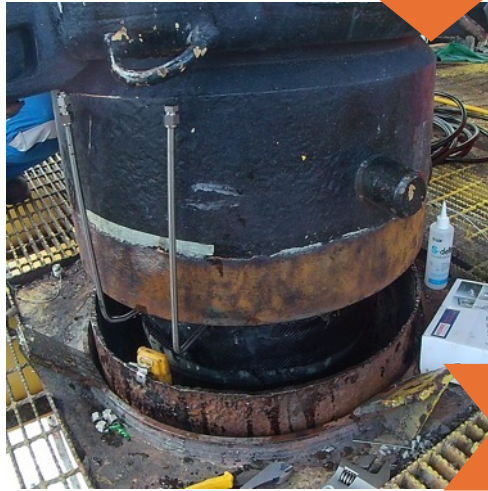
Leak Containment & Tubing
Installation

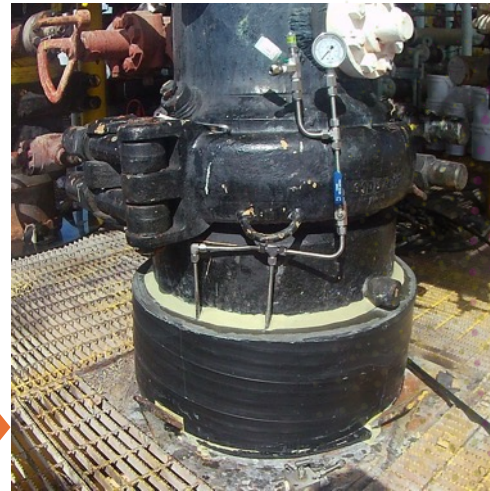
Completed Installation

- The Helicoid Epoxy Sleeve system reinforced the strength and leak containment of the defected wellhead. This repair extended the operational life of the wellhead without requiring full casing replacement.
