Installation of Helicoid RSS Epoxy Sleeve[®]

Caisson Repair
Services

Helang HIP

CAISSON REPAIR

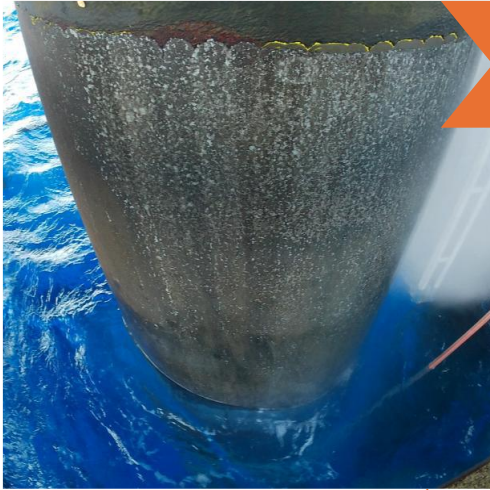
Surface Preparation

- To perform Surface Preparation via High Pressure Water Jetting removing the existing coating and marine growth.
- To perform leak containment using Helicoid RSS.
- To perform winding of HDPE sleeve with carbon fibre reinforcements
- To perform mixing and injection of epoxy grout for the Helicoid sleeve.

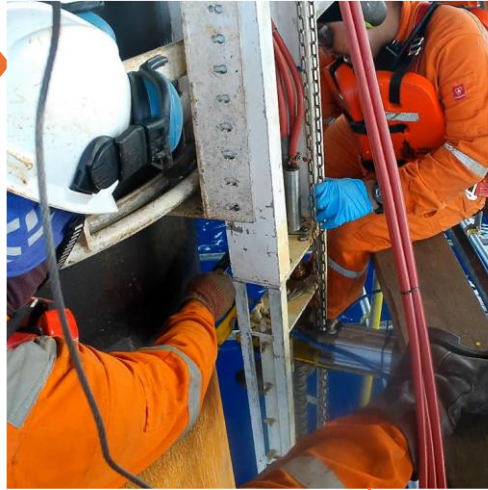
Helicoid RSS Installation

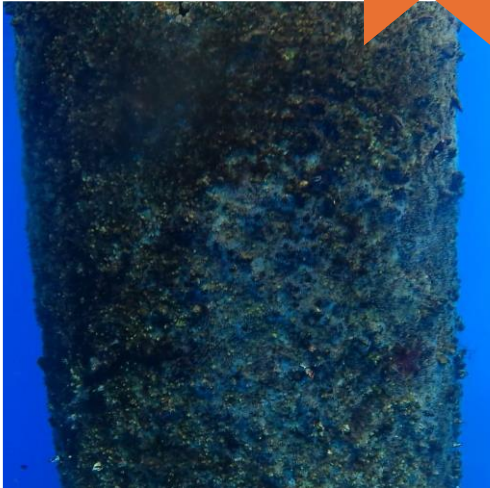
In June 2025 we had to undertake one (1) number of 40-Inch Caisson repair for leak containment and protection located offshore in the waters of Sarawak, Malaysia with a total 5m of repair length. The caisson had multiple leaks via pinhole punctures located along the axial length at multiple locations 3m under the MSL at the splash zone area.

Initial Condition

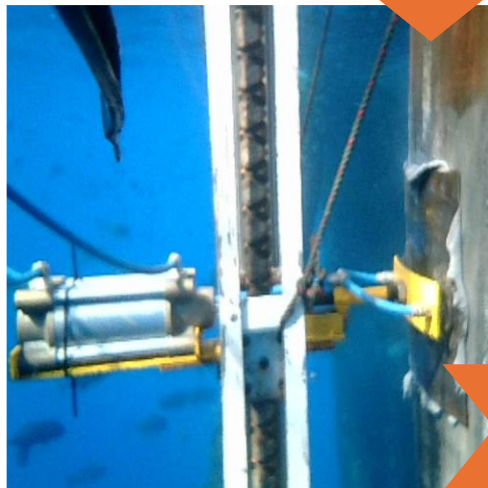
Patch plate being setup
neumatically

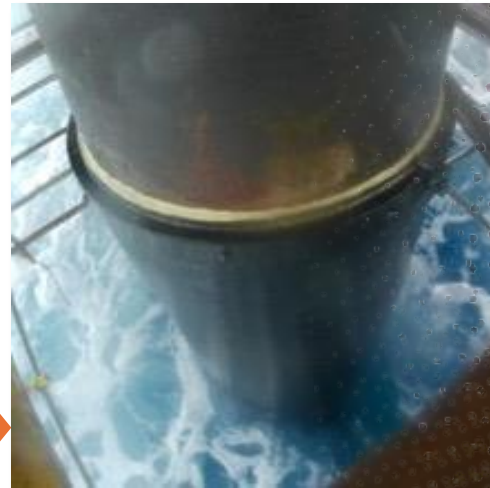
Completed Installation

- Caisson repair was successfully installed using Helicoid RSS system at the splash zone area. The leak containment was executed with out divers and an integrated diving vessel support. The hybrid system of patch seal and the Helicoid provided a long term solution at a fraction of the cost of a conventional repair method.
