Case Study

Installation of Helicoid Epoxy Sleeve[®]

Riser Repair Services

Shenzi TLP

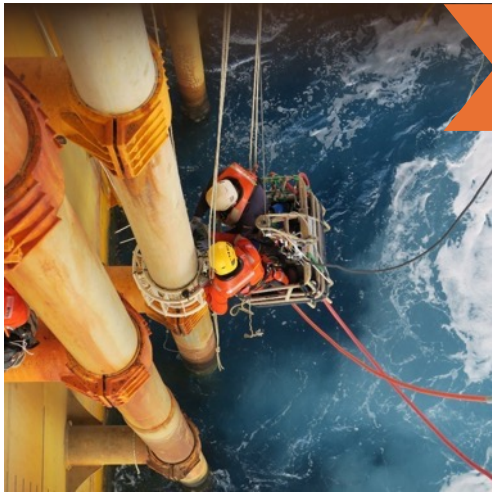
Winding Cage Installation

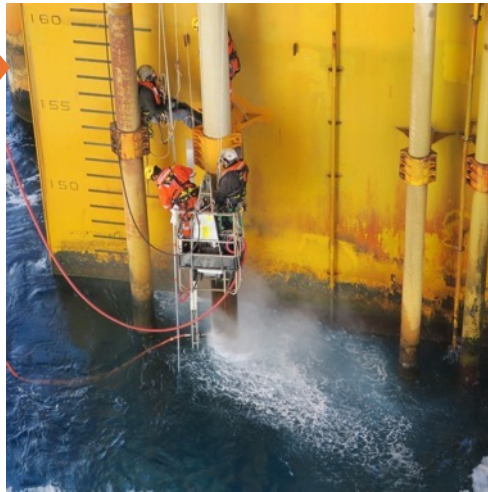
Surface Preparation

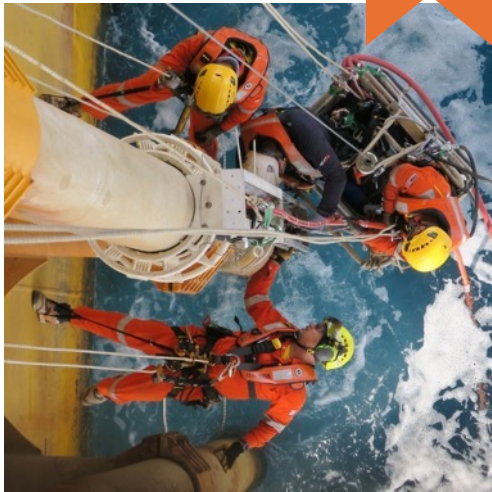
Blasting Frame Installation

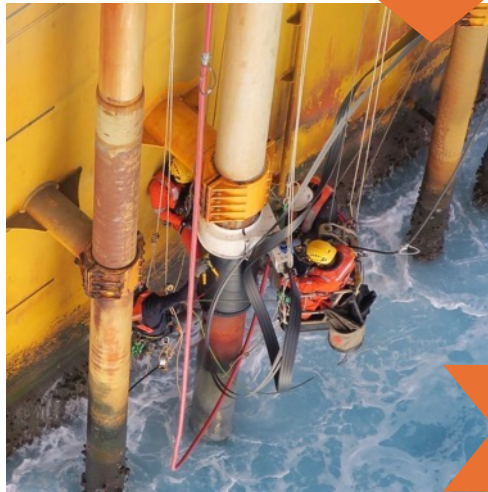
Winding HDPE
