# Case Study

Installation of Helicoid WRES Epoxy Sleeve<sup>®</sup>

Wellhead Casing  
Repair Services

UNAM-B

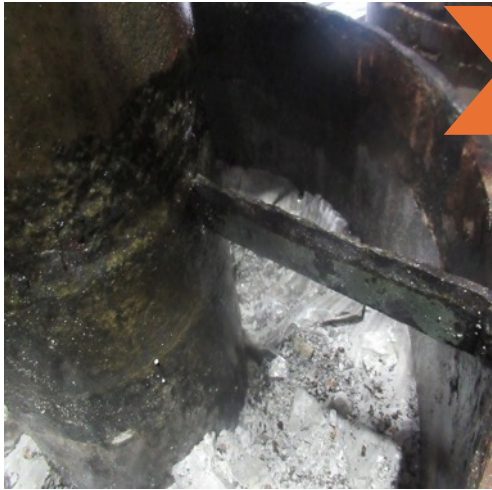
Surface Preparation

- To perform Surface Preparation via High Pressure Water Jetting removing the existing coating and marine growth.
- To perform Surface Preparation via High Pressure Water Jetting to dig up existing cement.
- Leak Containment (on Leaked Wellhead Casing)
- To perform winding of HDPE sleeve and Carbon Fibre.
- To perform mixing and injection of epoxy grout for the Helicoid sleeve.

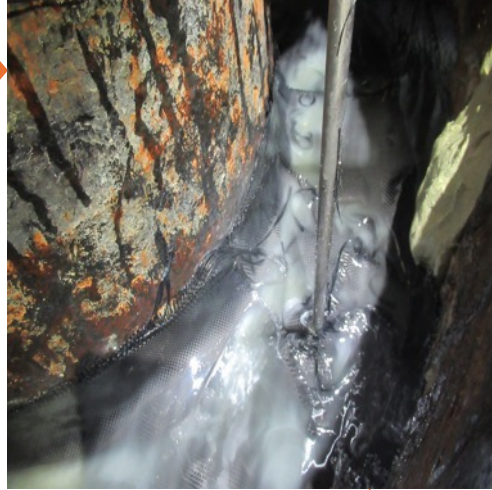
Leak Containment

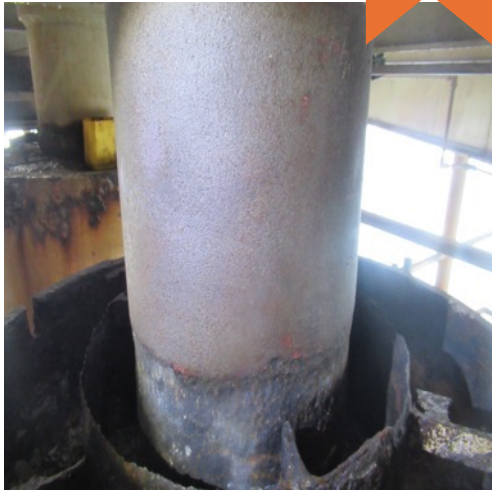
Original Condition

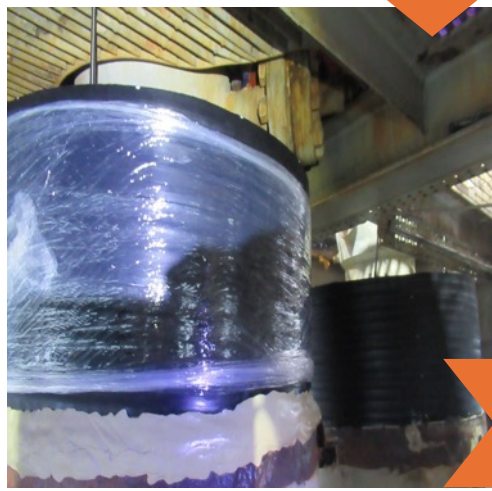
Winding HDPE

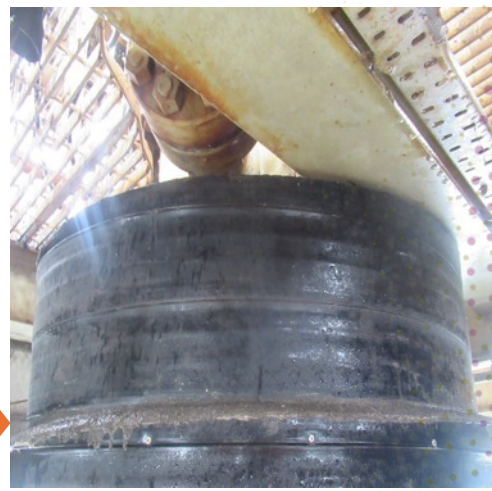
Completed Installation

- The Helicoid Epoxy Sleeve that was installed for the shallow gas leak repair have helped client to put the well back online and continue to produce.
