**SPE-220572-MS**

## **Unconventional Solution for Well Operation and Maintenance: A Successful Case History of Surface and Downhole Leak Repair Using Robust Chemical Sealant**

This paper was prepared for presentation at the SPE Symposium - Well Integrity Management held in Al-Khobar, Saudi Arabia, 21 - 22 May 2024.

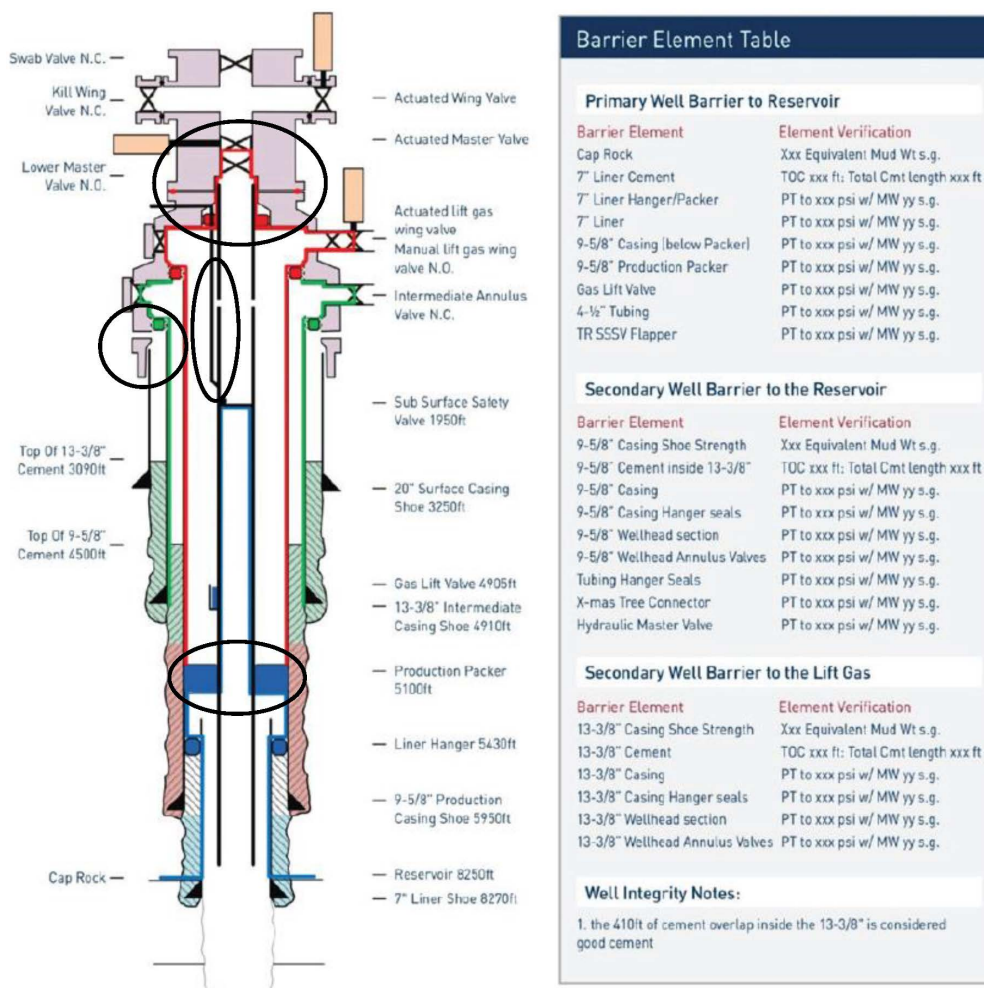
Figure 1—Well Barrier Schematic and Well Barrier Element table according to ISO/TS 16530-2:2013(E) technical standard with affected WBEs integrity to be reinstated in this campaign (in circle).

Leak occurrence is unavoidable during the operation and maintenance of an oil and gas well. A leak refers to the unintended escape or release of fluids, such as oil, gas, or other hydrocarbons, from a containment system or pipeline. These leaks can occur in various locations within the well construction, whether sub-surface or surface, compromising the well barrier elements (WBEs). According to ISO technical standards, there are approximately 26 typical modes of failures, and any simultaneous occurrence of two or more failures could severely worsen the integrity condition of a well (ISO/TS 16530-2, 2013) as shown in figure 1.

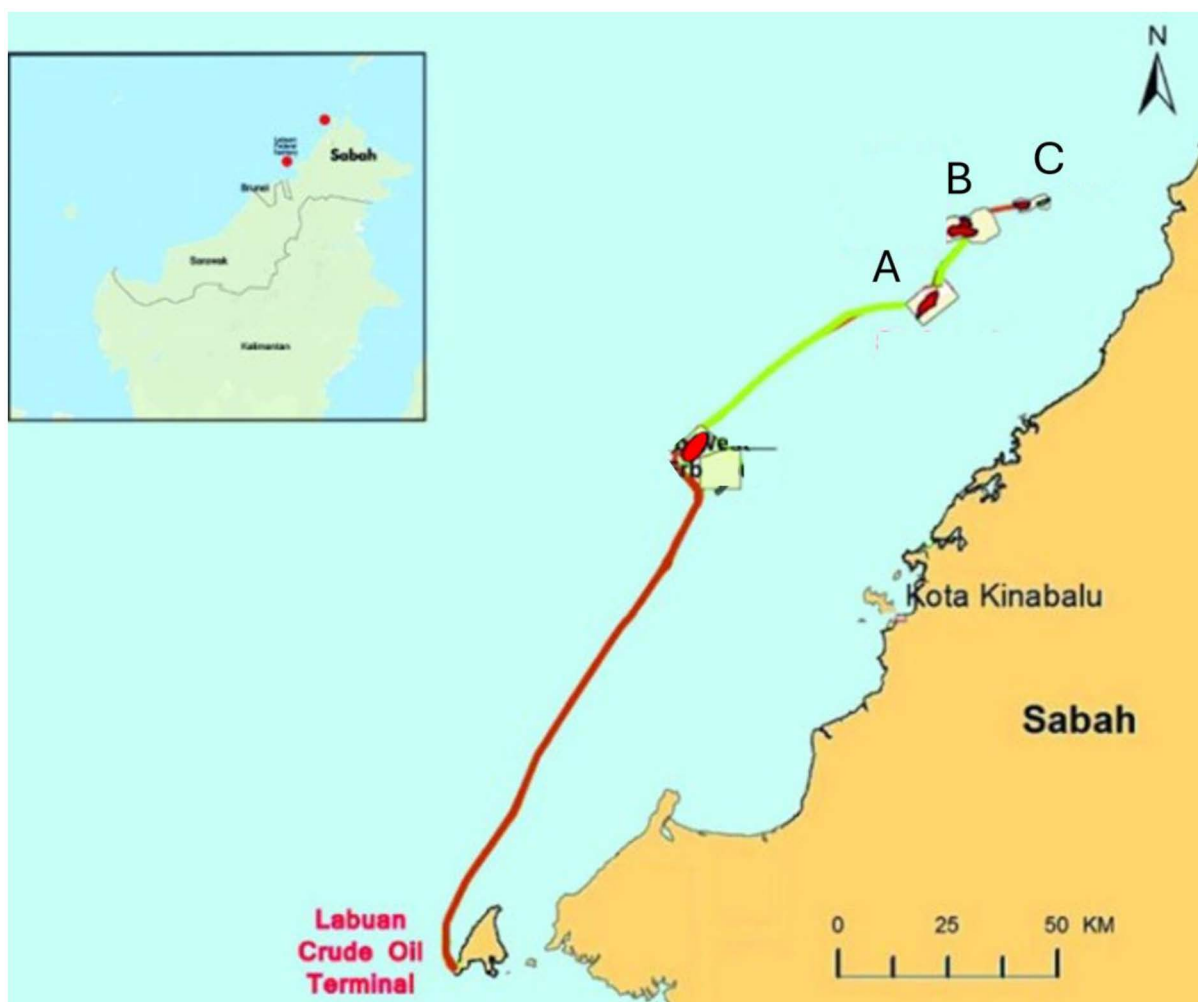
Figure 2—Location of each well leak repair candidate on Field A, B and C.

The location of the assets also varied from one location to another as shown in [figure 2](#), thus requiring proper project planning from the well operator.

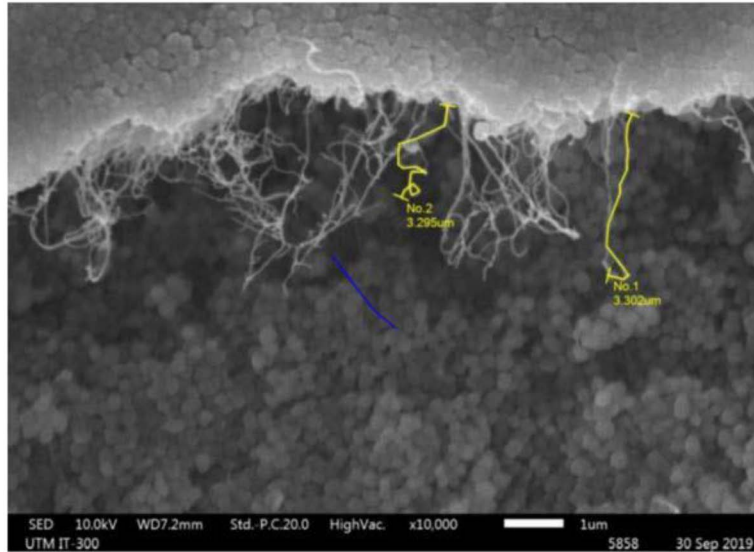
Figure 3(a)—20K times SEM micrograph of a solidified PAS

Pressure Activated Sealant (PAS) is a liquid sealant that solidifies at the site of a leak where a pressure differential exists. When pressure is applied, it generates a significant shearing force within the sealant flow at the leak point, prompting the sealant to transform into interlocking polymeric fibres as seen on [figure 3\(a\)](#), effectively sealing the leak. PAS possesses a viscosity akin to water, making it ideal for addressing minor leaks. Furthermore, this sealant is chemically inert and compatible with oil, gas, and water.

PAS has a specification of pressure rating of 10,000 psi and temperature rating maximum of 260 °C. Standard density and viscosity of the sealant is 12.6 ppg and 20 cP and can be modified and adjusted to suit leak scenario.

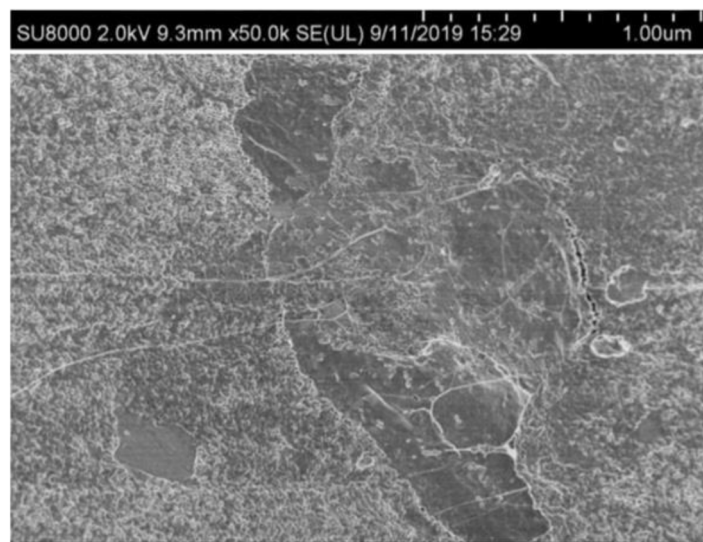
Figure 3(b)—500 times SEM micrograph of a solidified TAS

Time Activated Sealant (TAS) is formulated in liquid form and comprises two (2) components: a base fluid and an activator. These components must be thoroughly mixed and allowed time to cure, solidifying over time. The duration of solidification is influenced by factors such as temperature and the volume of activator added to the mixture. Figure 3(b) illustrates a scanned electron microscopy (SEM) micrograph of solidified TAS.

The activation mechanism involves polymerization resulting from the reaction between the activator and base fluid. This reaction transforms the mixed liquid into a solid state characterized by hardness yet slight flexibility. The solidified flexible polymer exhibits high tensile strength, enabling it to withstand elevated pressure and temperature conditions. Importantly, zero shrinkage occurs during the solidification process, ensuring comprehensive coverage over the leak area. TAS demonstrates resistance to most chemicals and is compatible with hydrocarbons or produced fluids.

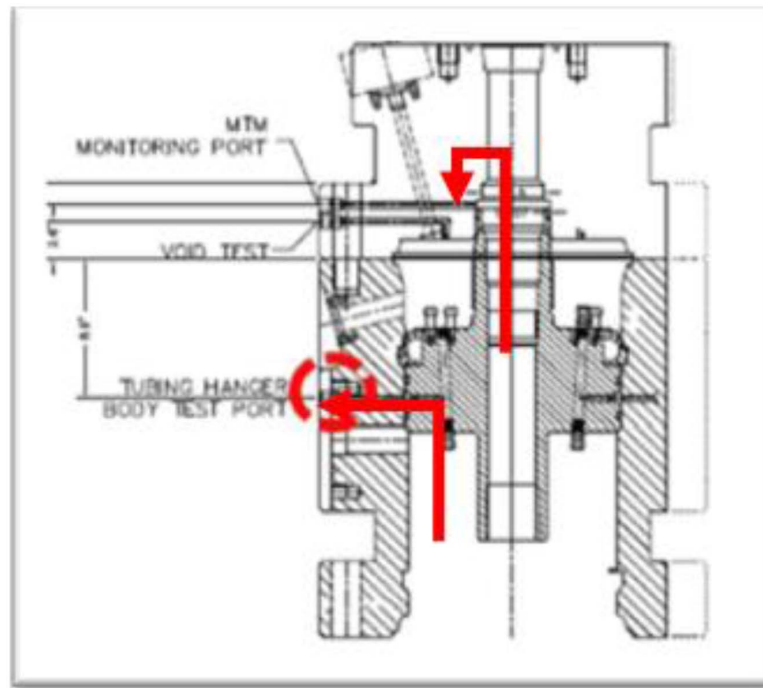
Figure 4—Potential leak path visualization using wellhead tree diagram or drawing.

The purpose of this step is to gather all data and summarize each leak potential based on operator data. When studying the data, the authors understand the potential leak path as shown in figure 4 and potential affected Well Barrier Elements (WBEs), and sometimes the severity of the leaks for better diagnostic and repair plan.

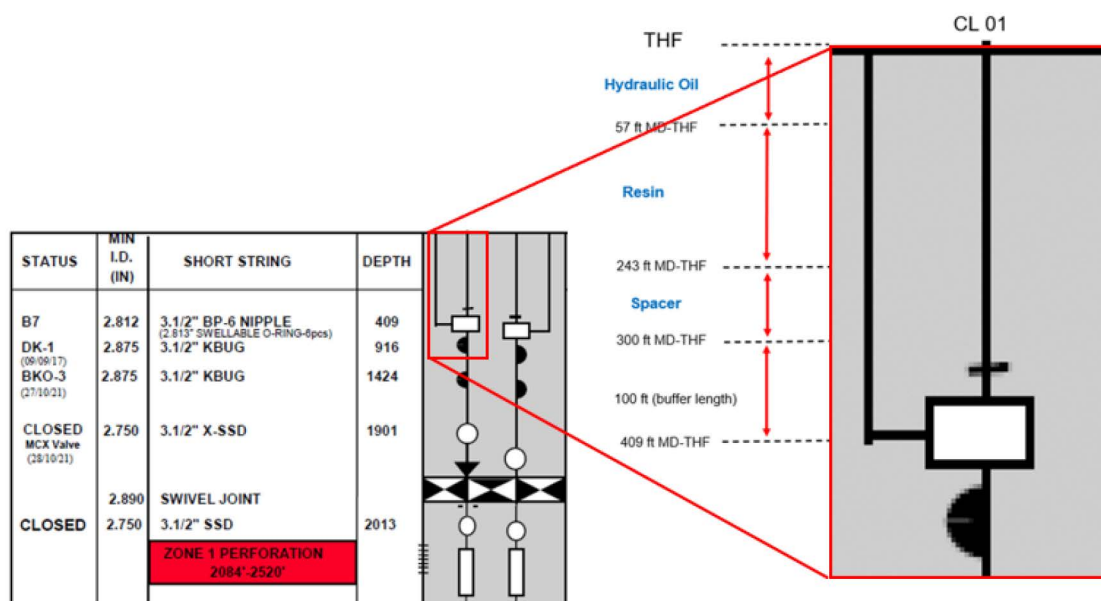
Figure 6—Typical CL schematic (zoom in) with depth in well CL 1

Diagnostic testing for control line leaks is similar to that of wellhead leaks. However, determining the leak depth relies solely on volume calculations of fluid during pressure manipulation on the surface. During this campaign, control line leak conditions were diagnosed primarily to understand the leak severity and injectability for the sealant deployment. Proper displacement is critical since over-injection of sealant might result in excess sealant exposure toward the MCX Valve underneath the Tubing Retrievable Safety Valve (TRSV) depth. An example of depth determination for volume calculation is shown in figure 6 below.

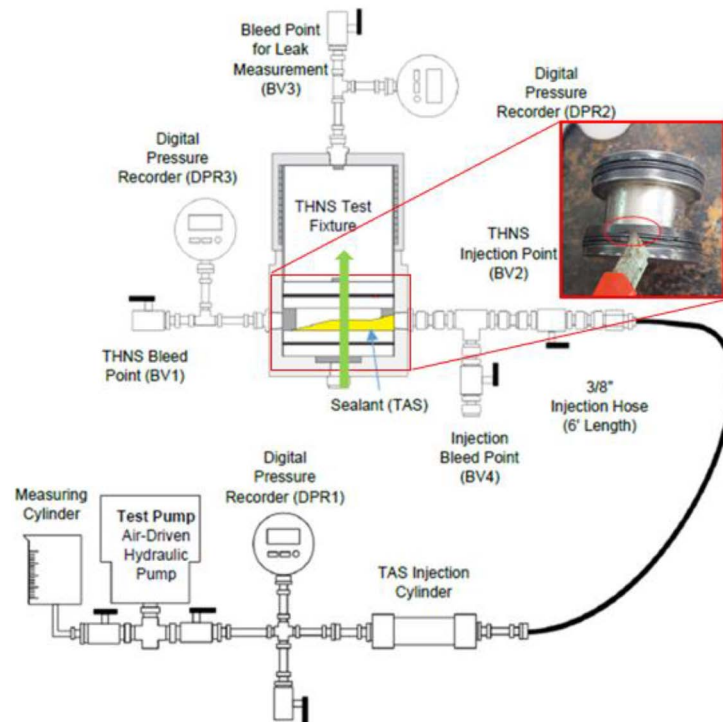
**Wellhead Leak.** Elastomeric seal damage in the wellhead is usually the culprit for any wellhead leak issues. The capability of the sealant to be injected into the wellhead monitoring port and seal the leak is simulated using a pressure-rated test fixture with an actual damaged wellhead seal complete with an injection cavity, as shown in Figure 7 below.

Figure 7(a)—Sealant injection setup for simulated wellhead seal leak rectification using TAS.

The results from this SIT provide us with confirmation of TAS's ability to seal the simulated leak flow path, indicated by the green arrow at 55 ml/min at 1500 psi. TAS was cured under a 600-psi curing pressure and created a competent seal capable of withstanding 2000 psi pressure during the integrity test. TAS was seen to cover the injection cavity of the test fixture, as shown in Figure 5, and thus did not excessively bleed out of the simulated leak cavity, as depicted in Figure 6. This further confirms the requirement of high pressure to ensure successful TAS application, in line with the sealant's working principle.

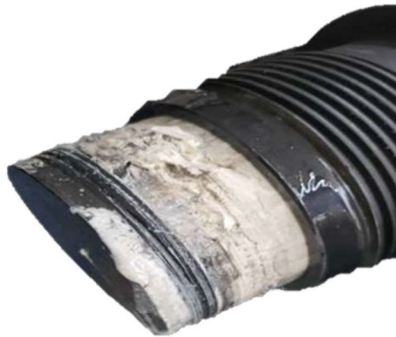
Figure 7(b)—A competent seal was observed when removing the simulated injection cavity.

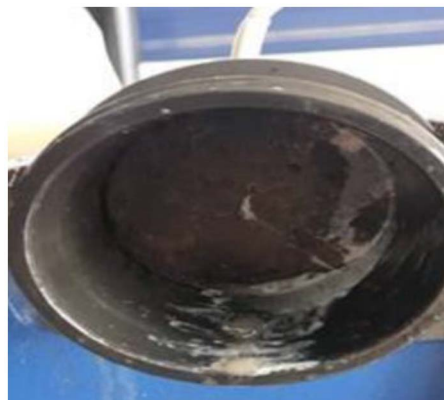
Figure 7(c)—No excessive sealant was squeezed outside of the injection cavity.

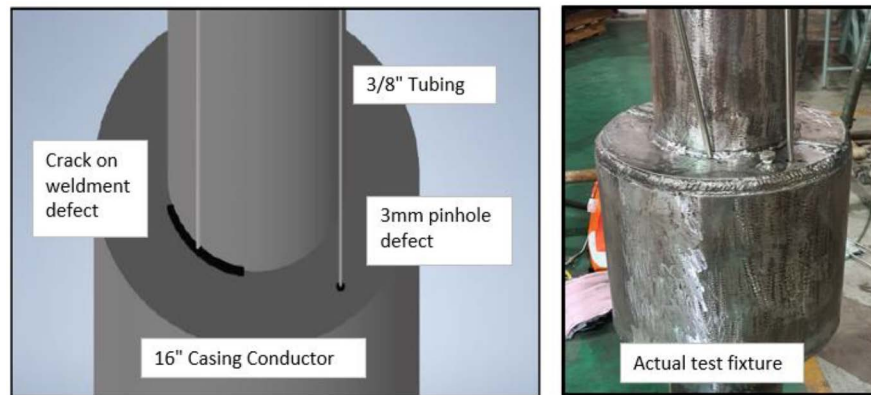
**Figure 8(a)—Initial SIT proposal vs actual test fixture fabrication to simulate casing conductor leak with pinhole damage and weldment defect.**

Referring to [Figure 8\(a\)](#), the test fixture was fabricated to replicate the repair application as closely as possible, thereby verifying the leak sealing methodology. A special Polyurethane (PU) sleeve served as a conduit for epoxy grouting, encapsulating the defect area. Prior to performing the final pressure test or integrity test after the curing process for 12 hours, as shown in [Figure 8\(b\)](#).

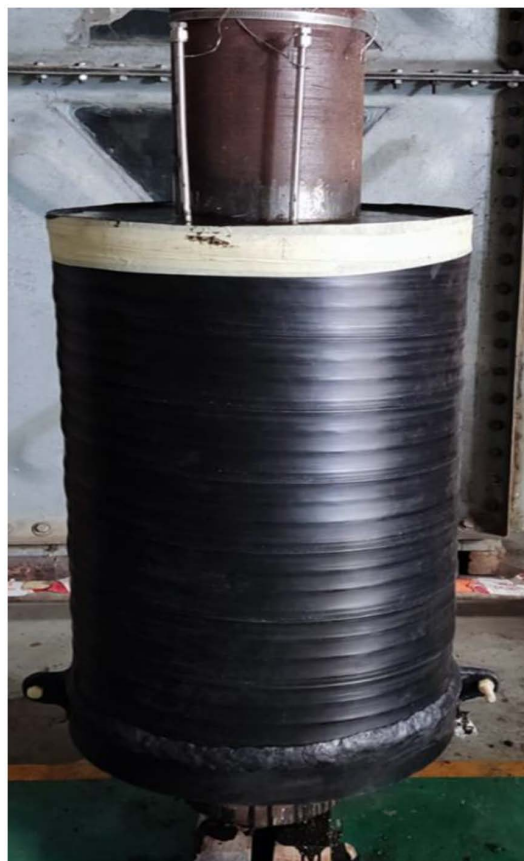
**Figure 8(b)—Conductor leak test fixture condition after tubing diverter installation and cured epoxy grout.**

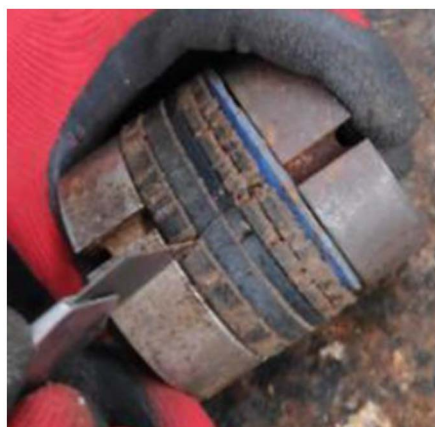
Figure 9(a)—Damage at elastomeric packing seal induce the simulated leak rate.

This test aimed to assess the effectiveness of the sealant (PAS) in sealing elastomeric packing seals within a simulated environment. This involved damaging the packing seal, as shown in Figure 9(a), and subjecting it to pressure tests within a controlled pressure chamber. The test measured the injectivity of the sealant both before and after the simulation, demonstrating its capability to seal the simulated leak effectively. As shown in Figure 9(b), the inactivated sealant in the pressure chamber remained in liquid form, proving that the sealant only activates at the leak path, as depicted in Figure 9(c). The excess sealant will not solidify if not activated. Additionally, the investigation delved into potential contamination effects, crucial for understanding real-world application scenarios and ensuring the reliability of the sealant under various conditions which yield similar results.

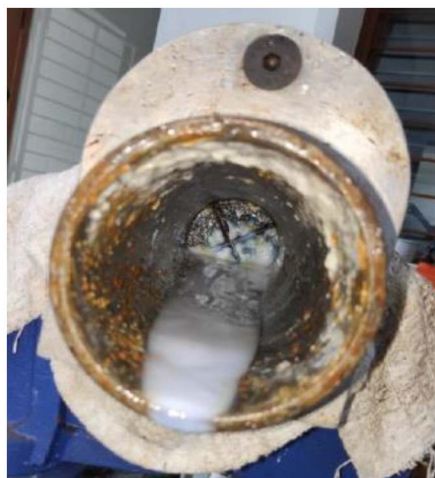
Figure 9(b)—Inactivated sealant in liquid form remain after depressurise pressure chamber for leak sealing simulation.

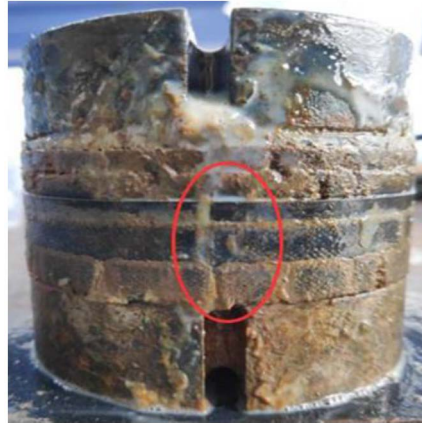
Figure 9(c)—Activated sealant in solid form observed across the leak path created competent seal.

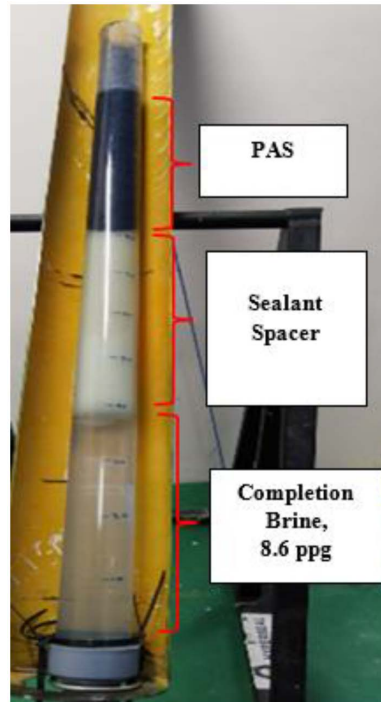
Figure 10(a)—Example of perfectly suspended sealant above the Sealant Spacer.

The objective of this test was to investigate the fluid train's capability to suspend the sealant during deployment. PAS was deployed within a translucent tube, and its behavior under static and dynamic flow conditions was observed. An example of perfect sealant suspension can be observed in Figure 10(a).

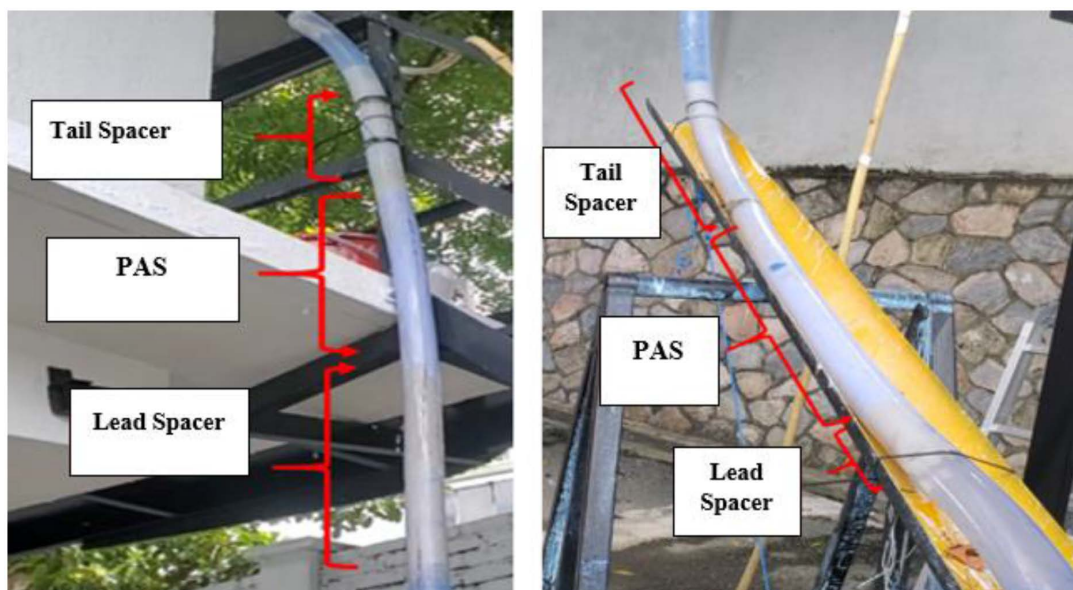
Figure 10(b)—Comparison of sealant deployment fluid slurry on vertical static condition (on left) versus dynamic flow scenario under simulated deviation angle (on right).

The sealant's suspension properties between lead and tail spacers were tested, as shown in Figure 10(b). The fluid train investigated was started with lead 8.6 ppg Spacer > 9.5 ppg Spacer > Pressure Activated Sealant > Tail 8.6 ppg Spacer.

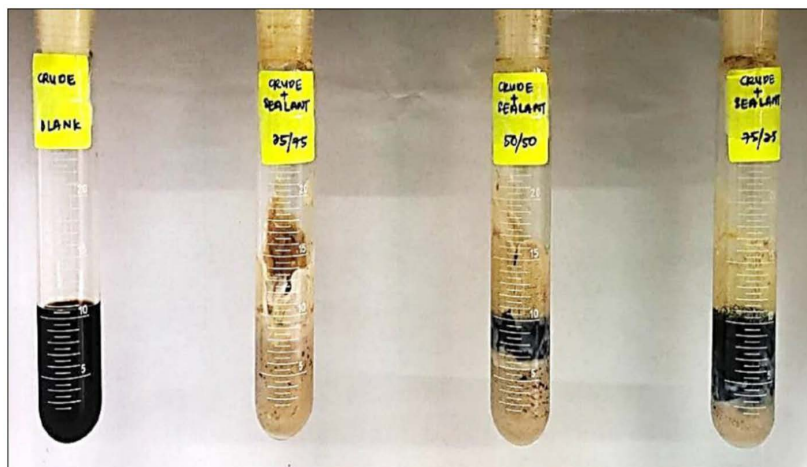
Figure 11—Example of sealant (PAS) compatibility test with crude oil under 90 degrees temperature.

The test focused on verifying the compatibility of the sealant and spacer fluid with crude oil and production treatment chemicals. It was performed in accordance with a simplified version of ASTM G170, the standard guideline for evaluating and qualifying oilfield chemicals in the laboratory. Test fluids underwent vigorous shaking and exposure to well temperatures to observe any emulsion formation, good phase separation, precipitation, or other physical changes. This ensured that the sealant and spacer fluid maintained their integrity and functionality when exposed to the harsh conditions encountered in oil and gas production environments. Figure 11 below shows an example of accepted test result of the sealant and crude oil compatibility under well temperature.

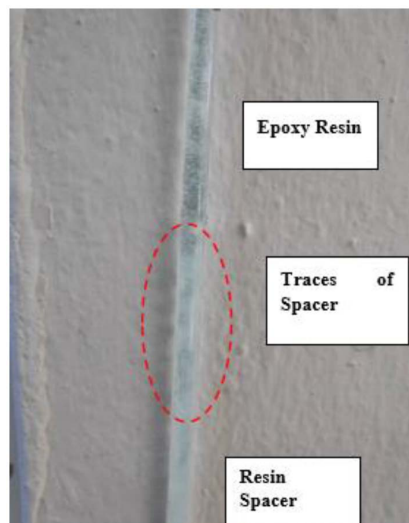
Figure 12(a)—Minimum traces of viscous spacer system observed not effecting the sealant deployment and curing process.

This SIT proved that the sealant was able to suspend between the spacer systems with minimal to no contamination of the sealant length, as seen in Figure 12(a). The sealant train was followed by hydraulic oil, and perfect separation of the hydraulic oil from the spacer system ensuing that the deployment method is accepted.

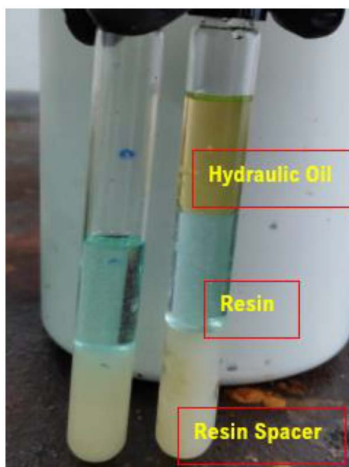
Figure 12(b)—Visible phase separation between spacer system and hydraulic oil chase fluid.

Thermal stability of resin sealant fluid train consists of sealant spacer, sealant plug and hydraulic oil chase fluid showing no immiscibility issues after submerged on 40° Celsius water bath as seen in figure 12(b). Again, the test was repeated using crude oil sample and subject to the vigorous shaken prior to simulate worst case scenario. Figure 12 (c) showed solidified section of the plug length proven the resin sealant capability to cure under contaminated environment, with some hydraulic oil separate at top of the plug. This further strengthens the deployment methodology to use spacer system during resin sealant deployment.

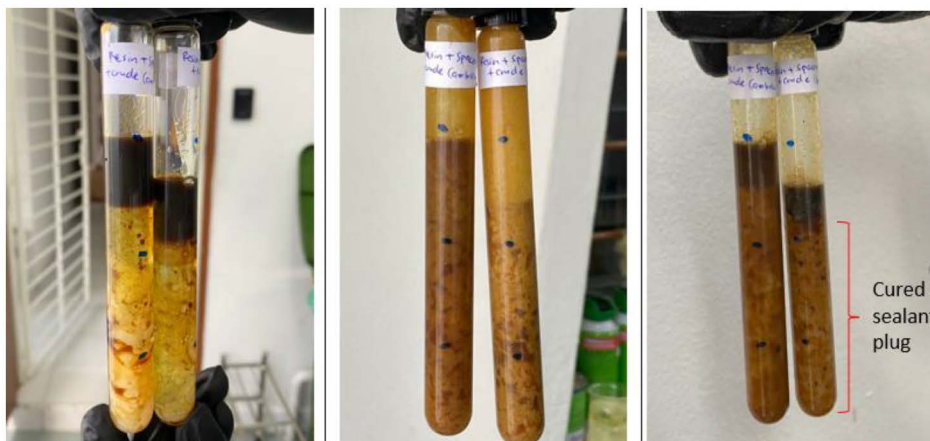
Figure 12(c)—From left to right, mixture of sealant spacer, neat resin sealant and crude oil, followed by shaken process and sealant plug condition after 24 hours curing process in 40° Celsius water bath.

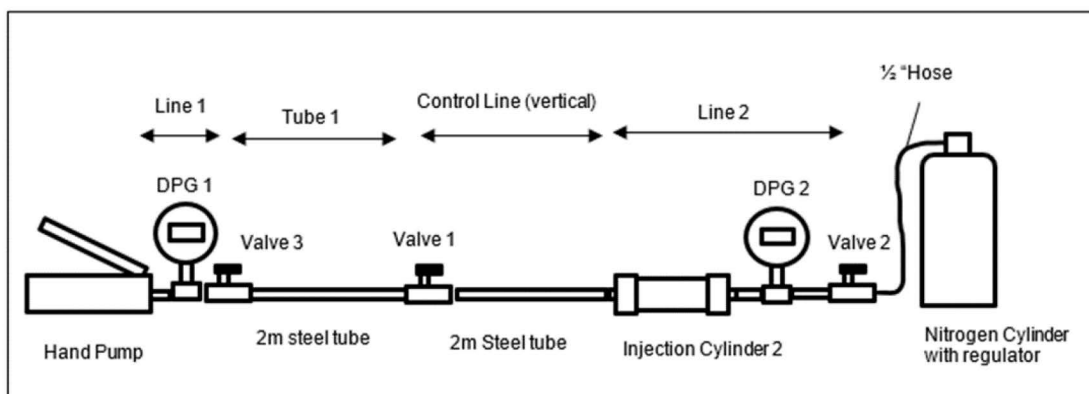
Figure 12(d)—Test setup for resin injection simulation with simulated downhole pressure using nitrogen gas.

Figure 12(d) depicts the final SIT setup, aimed at simulating resin injection pressure or back pressure inside the control line. The test involved simulating sustained pressure at one end of the control line and confirming the plugging capability of a column length of epoxy resin sealant in a 0.25-inch control line.

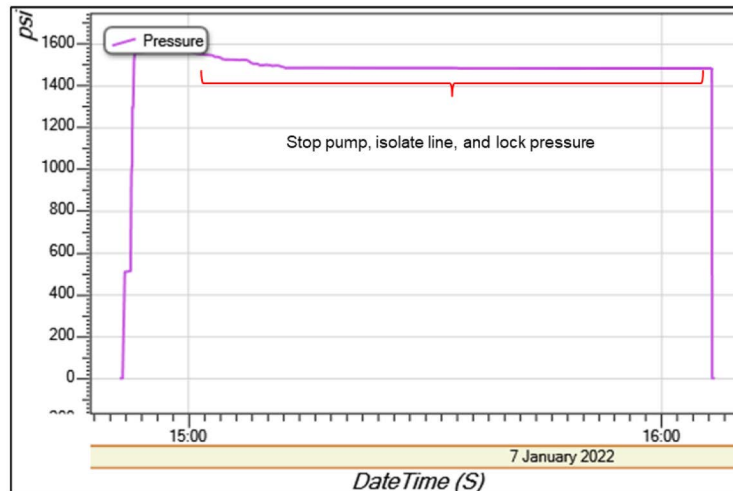
Figure 12(e)—Pressure test on 1 meter of cured epoxy sealant plug can hold up to 1400 psi.

Pressure test from both end of test setup was performed, and 1-meter cured epoxy resin plug can hold up to 1400 psi as shown in figure 12(e), thus meet the acceptance criteria of this resin plugging methodology. It is essential to note that the plugging of control lines (CL) typically involves a one-time application, and there is no turning back after the injection of epoxy resin sealant. Once the resin sealant has cured, it becomes inert to any fluid, leaving no option to reinstate the functionality of the control line back to normal.

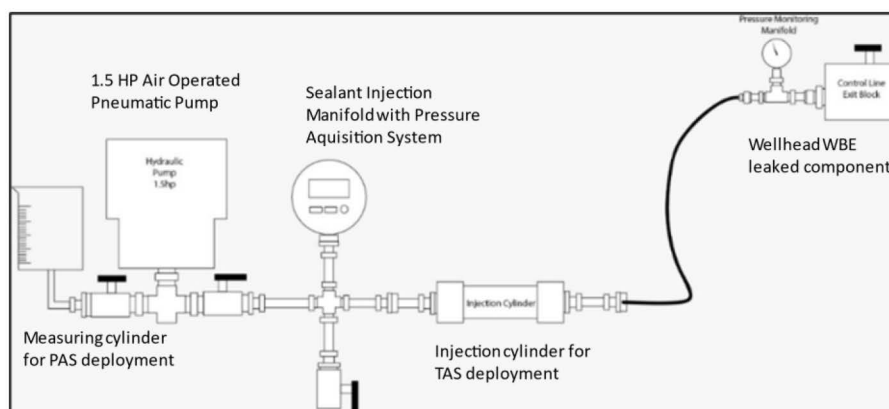
Figure 13—Typical layout of air operated pneumatic pump connection to wellhead WBE leak component for pressure and time activated sealant deployment.

**Wellhead and Control Line Leak Repair.** For example, rectifying a wellhead leak often involves utilizing a small pumping package capable of deploying liquid sealant at a certain flow rate and injection pressure. PAS requires a high-pressure and high-flow-rate pump to activate the sealant, whereas TAS requires the opposite. This can be achieved using an air-operated pneumatic pump. A typical sealant deployment for a wellhead leak can be seen in Figure 13.

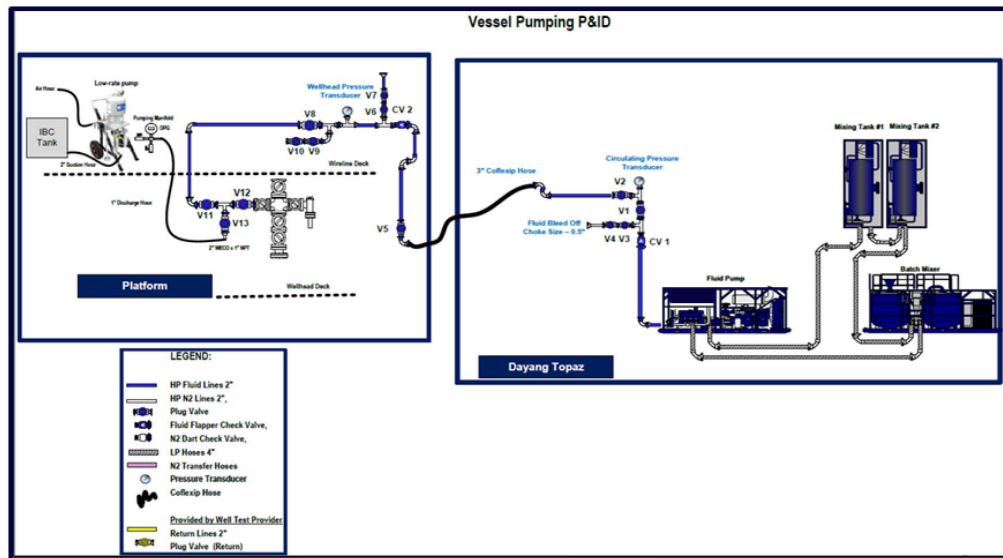
Figure 14—Typical sealant pumping setup for downhole packer leak repair via workboat assisted operation.

A proper sequence of sealant deployment procedures is crucial in orchestrating packer leak repair. Figure 14 shows a typical packer leak repair equipment setup with a fluid pumping fleet on a workboat and a sealant injection pump on the platform. The need for two separate pumps is to cater to a higher fluid injection rate during circulation using the triplex pump and a low-rate sealant injection pump to avoid sealant pre-activation at the pumping manifold.

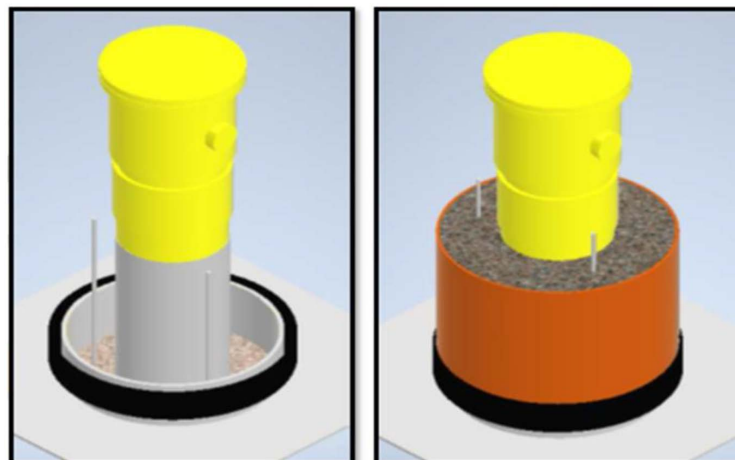
Figure 15—Rectification plan for conductor leak by removing existing cement, installation of gas diverter tubing line and completed with high adhesion epoxy sealant grout.

A surface cleaning tool is an important tool to achieve the SA 2.5 of surface preparation standard on the casing surface prior to the epoxy sealant grouting process. For example, on well C2 where the conductor is cemented up to the surface, 1 meter length of cement needs to be removed prior to vent line installation and epoxy sealant grouting process, as shown in Figure 15. This is to ensure that the composite repair can withstand high sustained casing pressure.

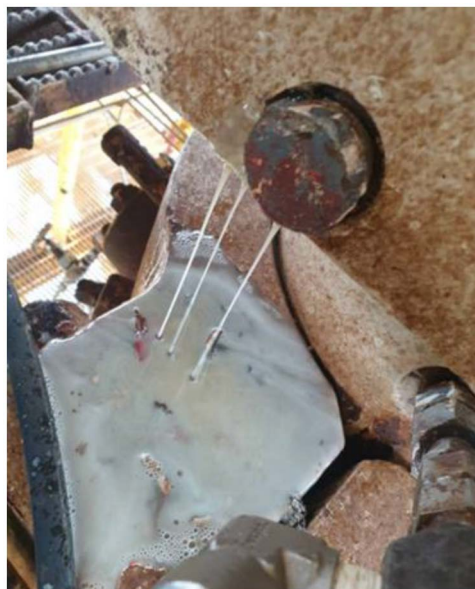
During the diagnostic of all the Well Barrier Elements (WBE), a pattern of leak conditions was observed. The leak intensity at the wellhead WBE was typically very small compared to leaks at the production packer. This discrepancy arises from the necessity to maintain the effective volume of the WBE. Wellhead leaks usually manifest internally and are only detectable through pressure changes during diagnostics. However, instances of leaks to the environment were rare, but one such occurrence was noted at well W3, as illustrated in Figure 16 (a).

Figure 16(a)—Unknown plug leaked when performing pressure test diagnostic on well W3.

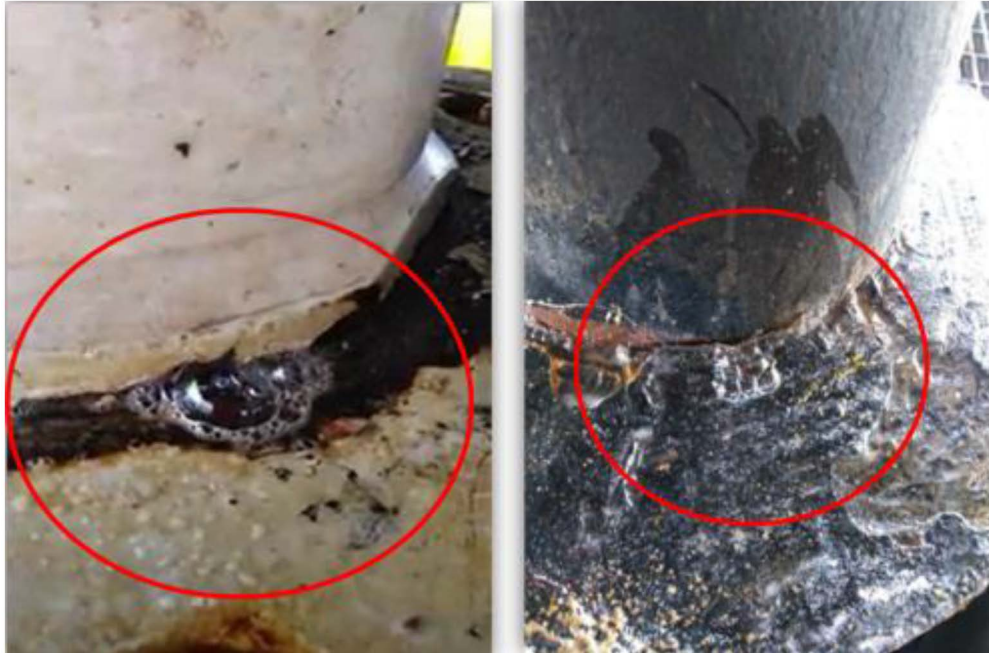
The leak on the conductor was very small, preventing the possibility of conducting pressure tests or negative tests. The severity of the leak could only be assessed by observing bubble formation at the surface and using a gas tester to measure Lower Explosive Limit (LEL) percentage readings. Surface leak conditions for wells C1 and C2 are illustrated in Figure 16 (b).

Figure 16(b)—Active gas emission at conductor surface area for well C1 and C2.

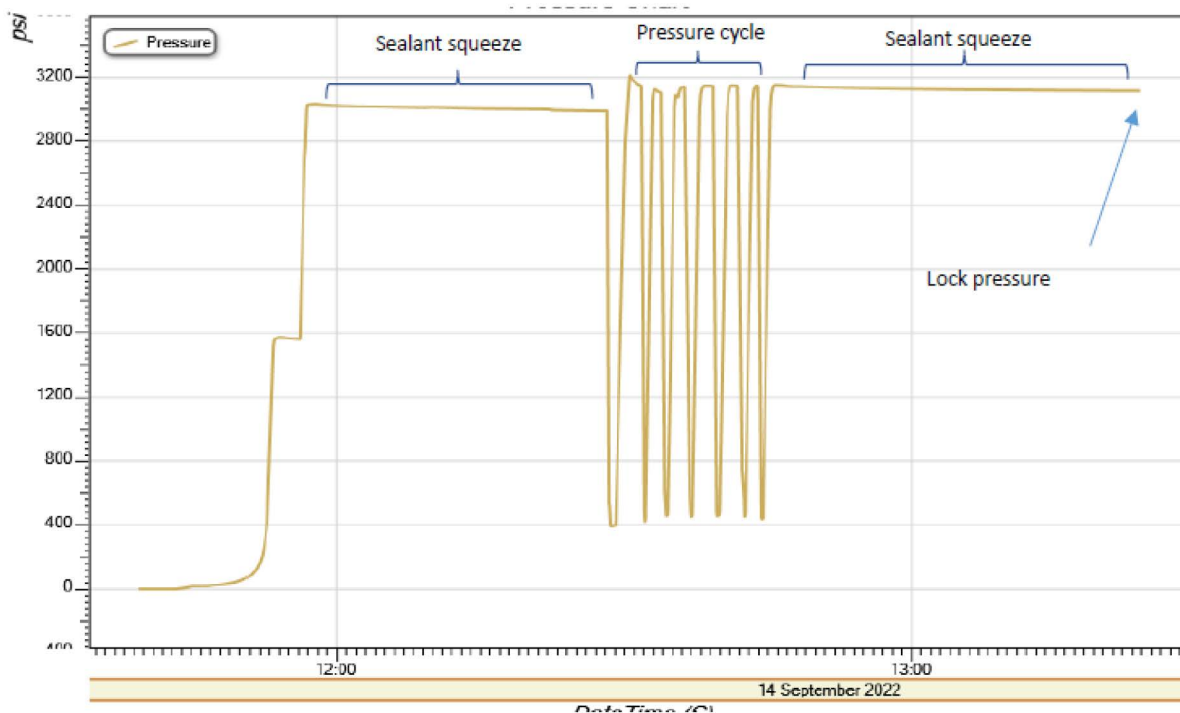
Figure 16(c)—PAS sealant deployment demands high squeeze pressure and pressure cycle.

Different injection methods are required in line with the sealant activation mechanism. When using PAS to address leaks, high injection pressure is necessary to activate the PAS in-situ at the leak path. Pressure cycling is introduced to expedite the intertwining process of active polymer in PAS, as depicted in Figure 16(c). The sealing improvement becomes evident after each cycle.

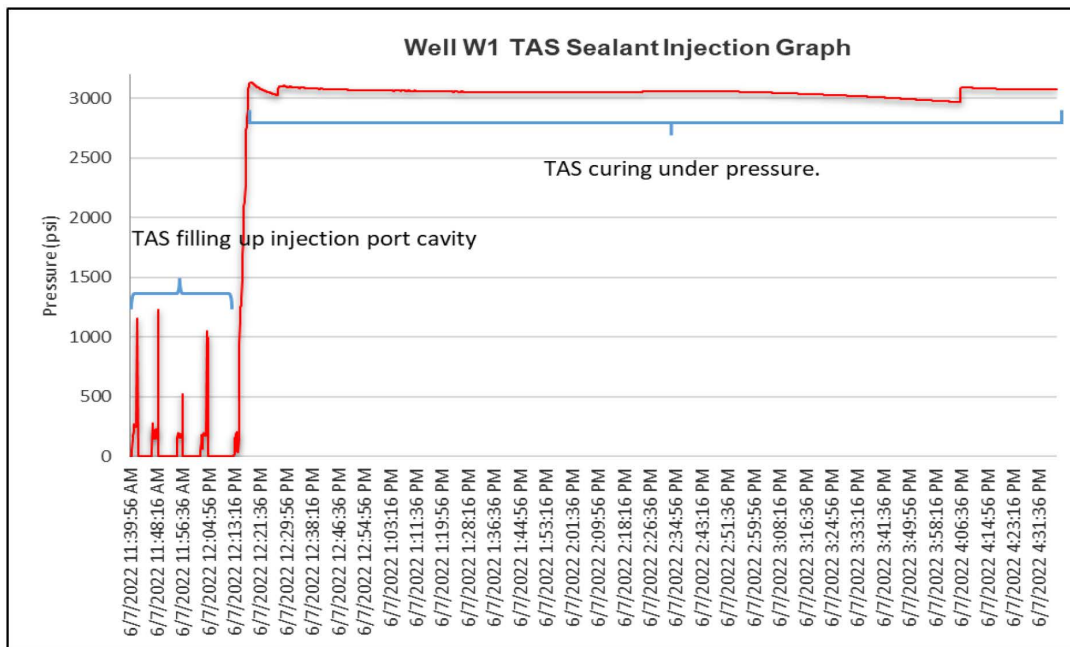
Figure 16(d)—Example of TAS sealant injection graph for W1.

Injecting TAS into damaged seals also requires high injection pressure due to the viscosity of the sealant. Figure 16(d) illustrates the TAS injection process, where the pressure drop indicates TAS liquid propagation into the circumference of the test port seal cavity. Each port allows for a different amount of sealant to be injected, depending on varying leak conditions. Upon completion, TAS is left to cure under pressure for 12 hours.

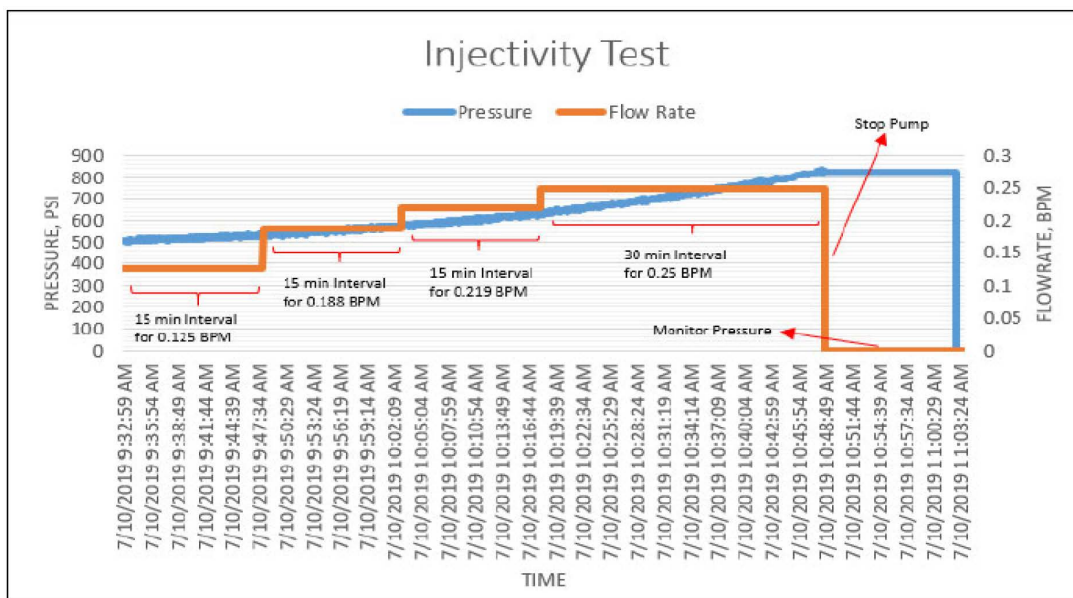
Figure 16(e)—Injectivity rate test for packer in well P1 before reaching maximum allowable pumping pressure.

**Packer Leak Diagnostic and Repair.** The injectivity rate test was an important step procedure for determining the leak severity of the packer. The injectivity rate vs injection pressure data plot as figure 16 (e), will be used to set maximum pumping rate and sealant pumping duration.

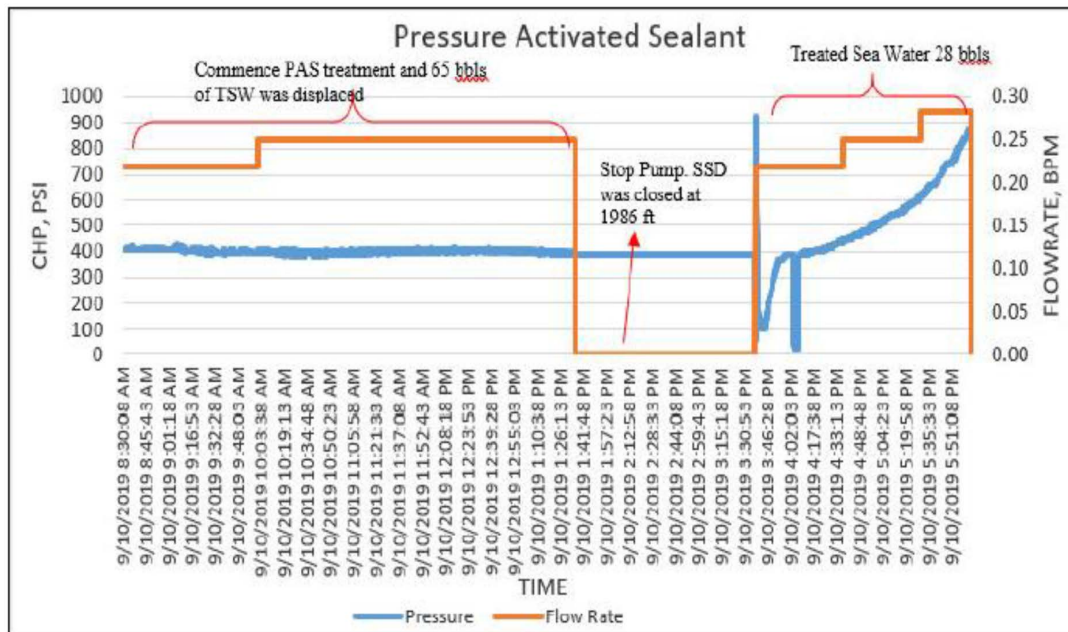
Figure 16(f)—Injectivity rate test for packer in well P1 before reaching maximum allowable pumping pressure.

Figure 16(f) below shows the actual PAS pumping sequence together with wireline entry to close the SSD. During circulation down the annulus, a constant pumping pressure was registered, indicating only friction pressure between the sealant fluid train completion. After closing the SSD, it can be observed that injection pressure starts to increase, indicating the sealant reached and attempted to seal the leaking packer. An adequate chase fluid volume is required to squeeze the sealant onto the leaked packer.

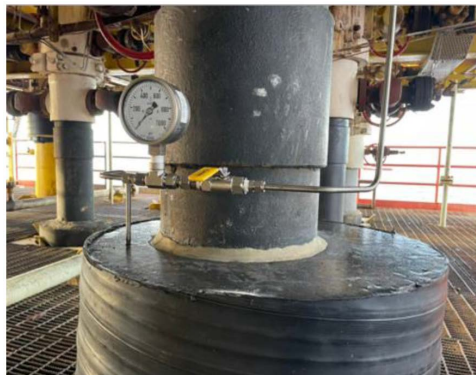
Figure 16(g)—Successful composite repair work using epoxy grout chemical sealant with tubing diverter installation for pressure management.

**Conductor Leak Diagnostic and Repair.** The application of conductor leak diagnostic and rectification is straightforward. The leak was diagnosed through physical observation, and LEL% readings were measured to assess the risk. The composite repair system, utilizing epoxy grout chemical sealant widely employed in the pipeline industry, was applied to this production well. Successful conductor leak repair was achieved on both well C1 and C2 after deploying 500 Liters of epoxy resin grout, respectively as depicted in figure 16(g).
