SPE-221807-MS

Epoxy Helicoid Sleeve for Conductor Casings: An Approach to Enhance Structural Integrity and Corrosion Resistance in Offshore wells

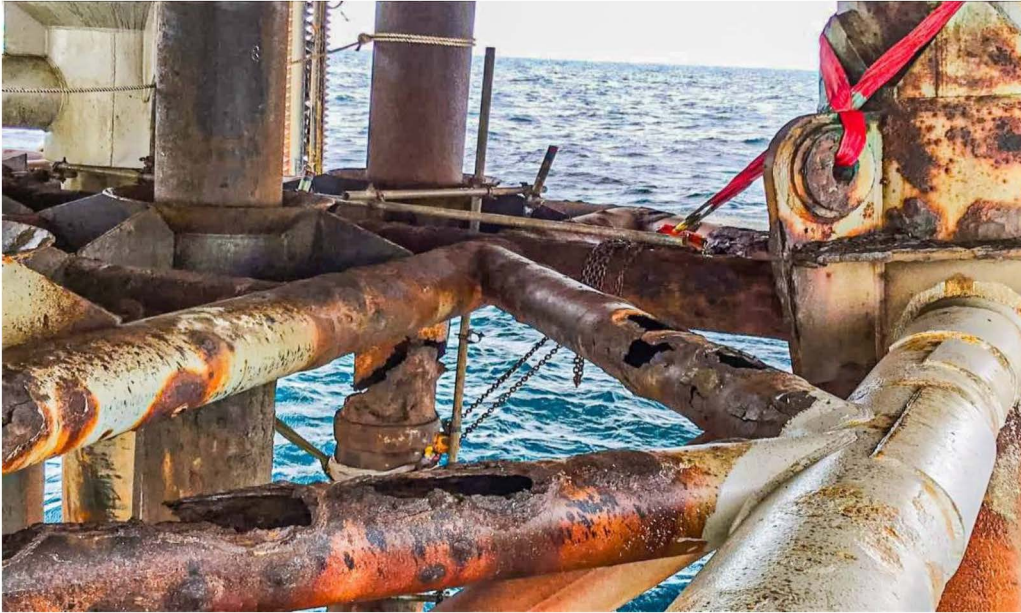
Corrosion at the splash zone, if left unchecked, can have catastrophic consequences for the platform and its crew. In the case of the well conductor, the most critical concern is perforation and parting as shown in Figure 2. As corrosion eats away at the conductor wall, its thickness is reduced, compromising its ability to protect internal casings and reduce its load bearing capability. This weakening can lead to internal casings being breached, allowing uncontrolled flow of hydrocarbons to the surface, posing a significant

safety and environmental hazard. It will also lead to crushed conductors, damaging the internal casings, the surface equipment, the wellheads, and the Christmas tree setups. A parted conductor, completely severed by corrosion, can result in a catastrophic event with potential for loss of life, environmental damage, and immense economic losses.

Figure 2—Perforated and Parted Conductor Casing

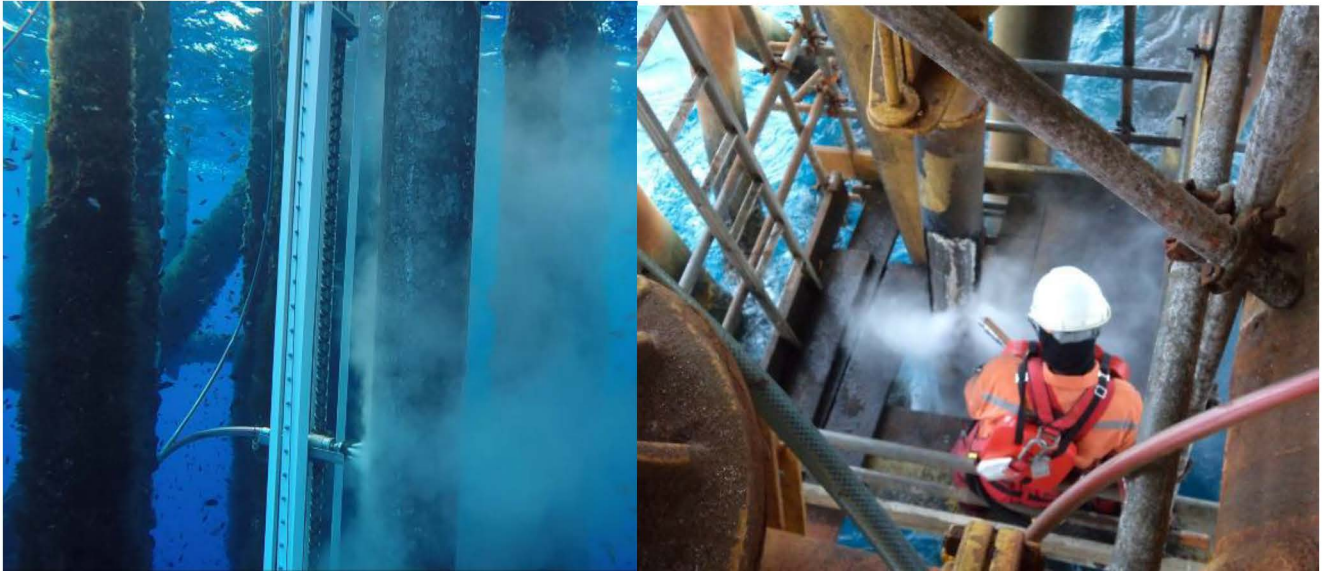
The installation of the Helicoid Epoxy Sleeve consists of three major steps. The first step is to perform surface preparation to remove existing debris, coating, marine growth, corrosion, and any oil residue on

Figure 7—Riser Surface Preparation by Hydro Blasting for Underwater and Above water

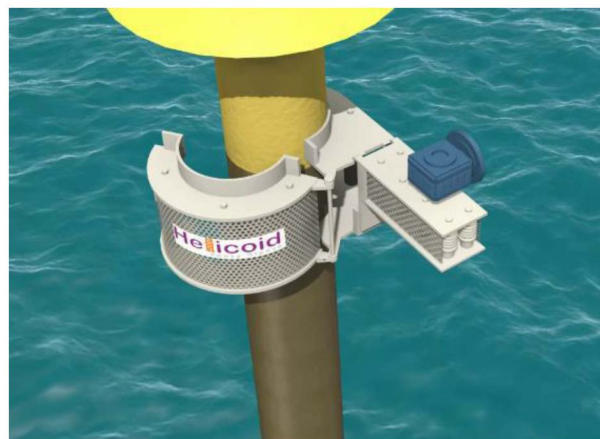
The second step of the installation is to wind the carbon fiber-reinforced HDPE sleeve. For this activity, another specialized equipment called the Helicoid Winding Cage (HeliCage) system is used. Designed specifically for each pipe size, the winding cage will be clamped and secured on the pipe, as shown in Figure 7. The carbon fiber reinforced HDPE strip will then be inserted into the winding cage to form a sleeve around the conductor, leaving an annulus of 30mm to 40mm between the pipe to the outer sleeve as shown in Figure 8. After winding of around 1 meter, the sleeve is trimmed at the bottom and an end cap is installed. The end cap serves as the sealing mechanism for the sleeve to ensure there will be no epoxy grout leaking through the bottom of the sleeve during the grouting process, as Figure 9. After that, the winding process will continue until the overall length of the repair is achieved, as shown in Figure 10. The sleeve is then trimmed at the top and secured by using bracket to prevent further movement.

Figure 8—Typical Installation of Winding Equipment

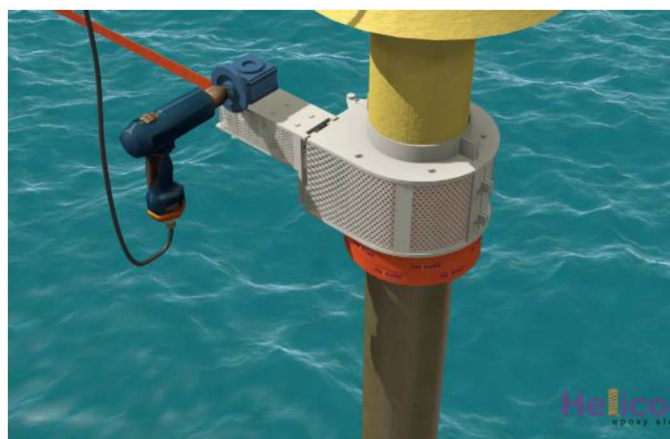
Figure 9—Insertion of Carbon Fiber Reinforced Strip

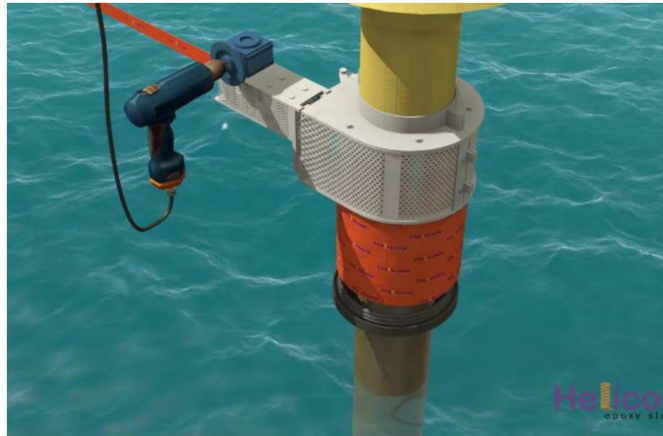
Figure 10—Fixing of Polyamide End Cap

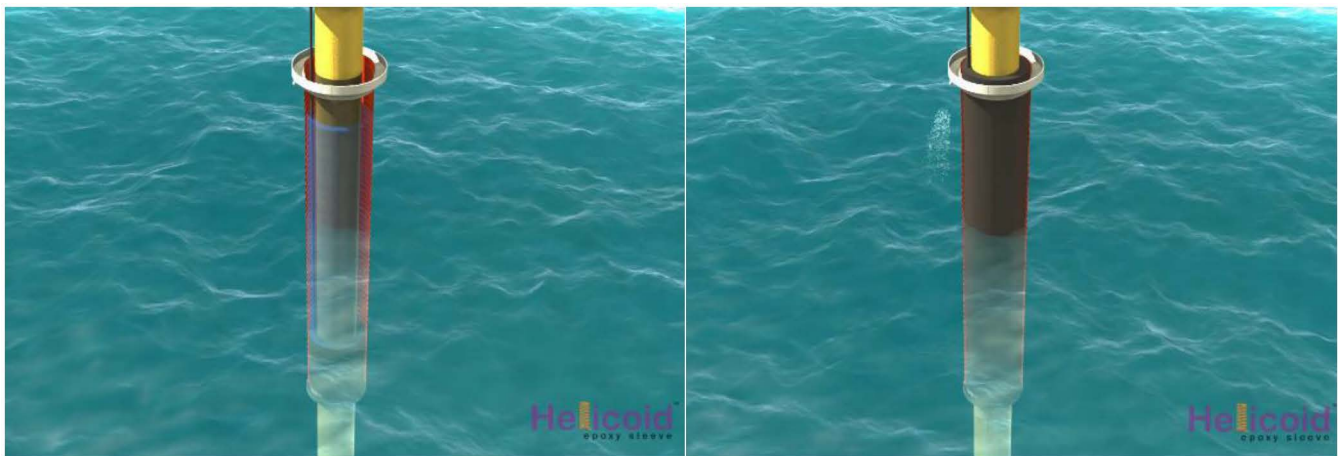
The last step of the installation is to perform the epoxy grouting activity by injecting a proprietary high strength epoxy grout (HeliGrout) into the annulus. The grouting activity is done in accordance with the Tremie method, where the hose is inserted into the annulus until it reaches the lowest point, followed by epoxy injection through the hose. By doing this, the epoxy grout will fill in from the bottom part of the sleeve towards the top. Since epoxy grout is denser than sea water, the epoxy will push up the water towards the top of the sleeve where the water will be displaced, and the epoxy grout will completely fill the sleeve, as in Figure 11. After the epoxy grout cured, the final step is to install the top end cap to prevent water pooling on top of the sleeve.

Figure 12—Injection of Epoxy Grout via Tremie Method

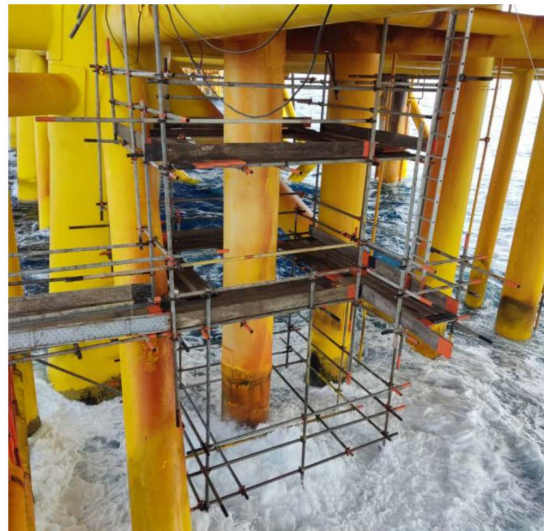
- Prior to the mobilization of the installation team, scaffoldings were erected at the splash zone level around the conductor to be repaired. There were two or three stages of the scaffoldings, one is around one meter from the MSL and the other is around three meters from the MSL. These are the working area where the manpower and equipment will be located at, as shown in [Figure 13](#).

Figure 14—Scaffolding Erection

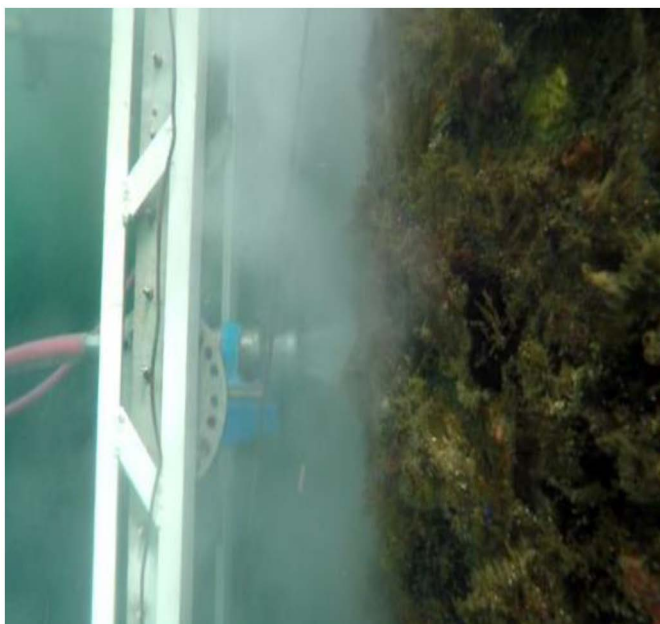
- The installation process started by marking the top of repair section on the conductor, in this case at EL +10ft.
- The HeliSurp system was utilized for the surface preparation process, from EL. (+) 10 ft until EL. (-) 10 ft m to completely remove marine growth and existing coatings until the conductor reaches bare metal. Upon completion, visual inspection was conducted by using an underwater camera for the below water section.

Figure 15—Surface Preparation Underwater

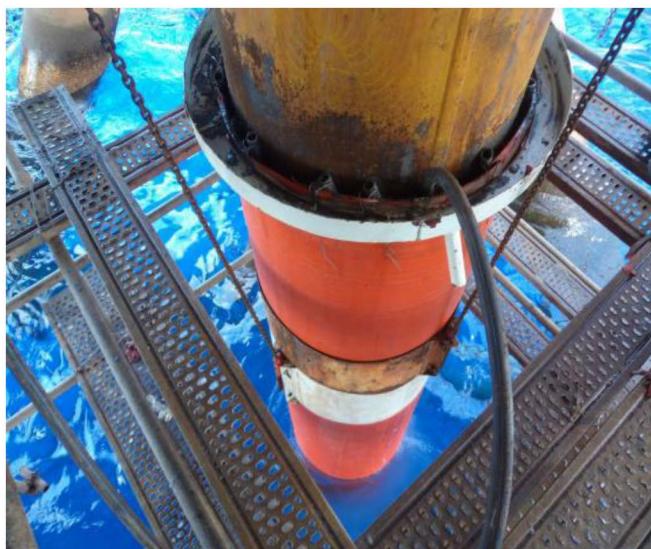
- The annulus between the sleeve to the conductor pipe is then filled by using HeliGrout, a proprietary epoxy grout. A grout mixer and pump are used to mix and the pump the epoxy grout. The grout is injected by using a hose that is placed at the bottom-most part of the sleeve to ensure that water is completely removed from the system, as shown in [Figure 14](#). An underwater camera was deployed throughout the installation to monitor the bottom of the sleeve, ensuring that there was no epoxy leakage during the activity.

Figure 17—Injection of Epoxy Grouting

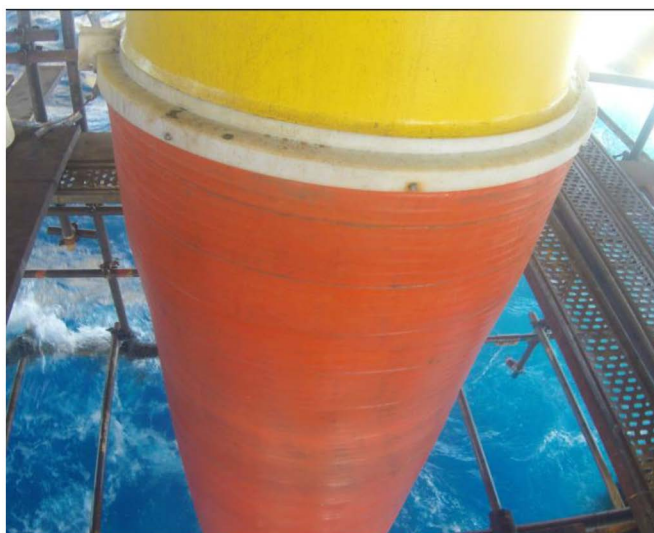
- The installation was completed by the installation of the top end cap upon the curing of the epoxy grout. It served to prevent any water pooling on the top of repair which will lead to corrosion, as shown in [Figure 17](#).

Figure 18—Completed Helicoid Epoxy Sleeve System
