Case Study

Installation of Helicoid Epoxy Sleeve[®]

Riser Repair Services

EDOP-B

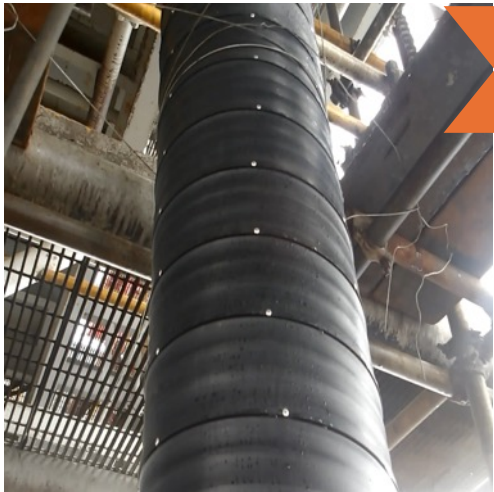
Winding HDPE

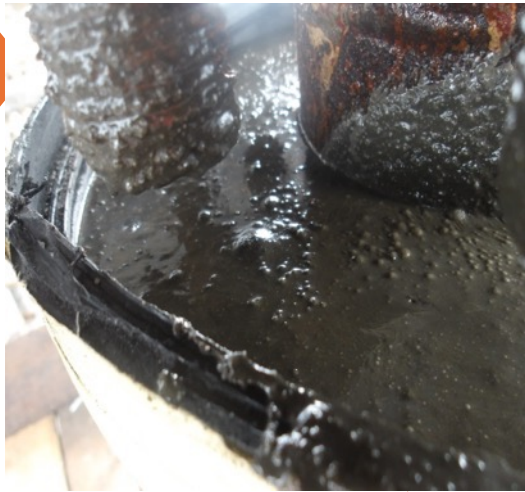
Epoxy Grouting

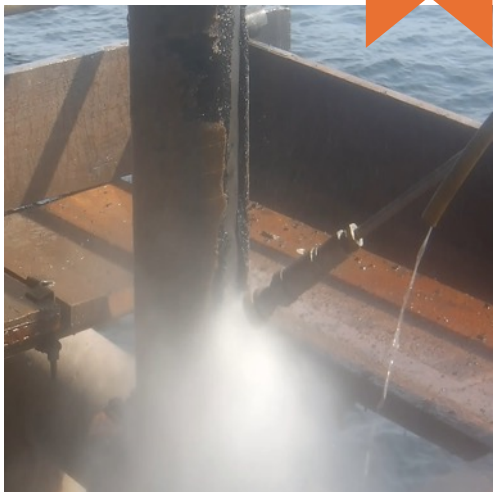
Surface Preparation

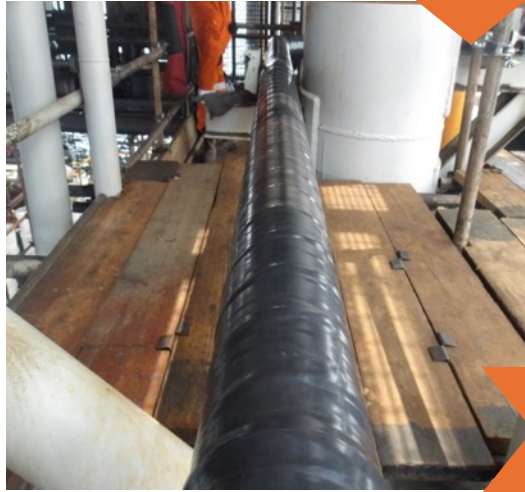
STOPAQ Wrapping

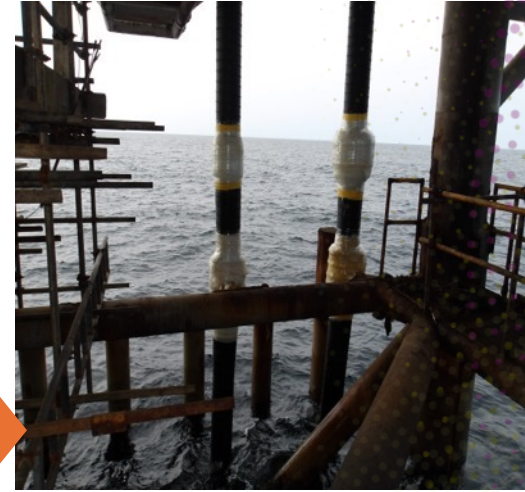
Completed Installation
