Installation of Helicoid Epoxy Sleeve<sup>®</sup>

## CONDUCTOR REPAIR

Seplat Energy

UNAM-B

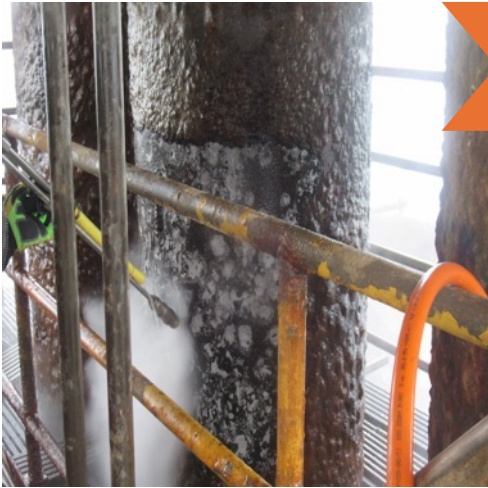
Surface Preparation

- To perform Surface Preparation via High Pressure Water Jetting removing the thick rust and existing coating.
- To perform winding of HDPE sleeve and Carbon Fibre.
- To perform mixing and injection of epoxy grout for the Helicoid sleeve.

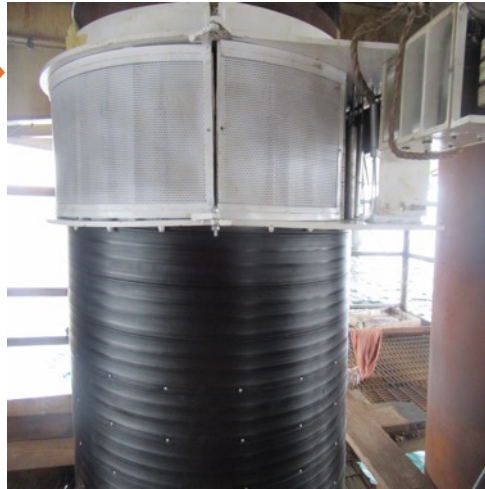
Winding HDPE

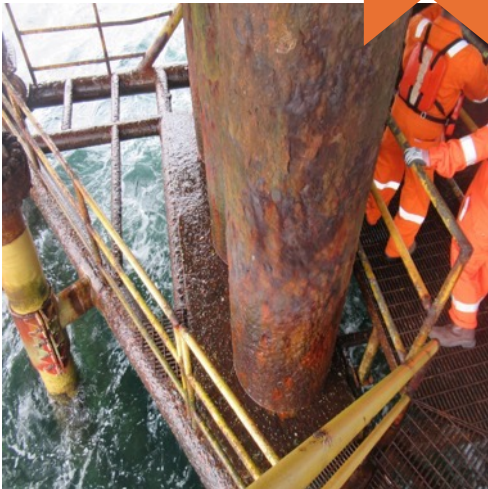
Original Condition

In October 2024, Merit Technologies Sdn Bhd with WEAfri Well Services Company Limited to undertake four (4) numbers of corroded conductors for strengthening and protection located at offshore in the Gulf of Guinea with total 7m of repair length.

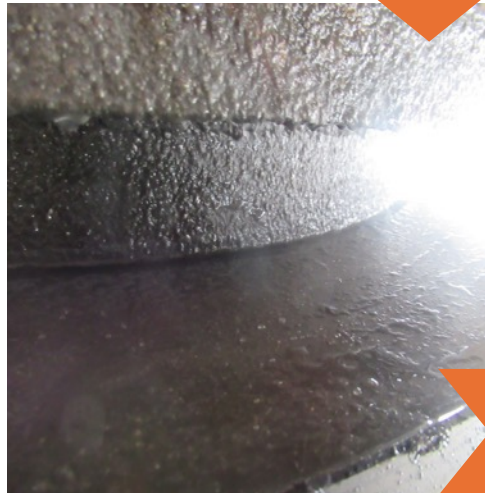
Epoxy Grouting

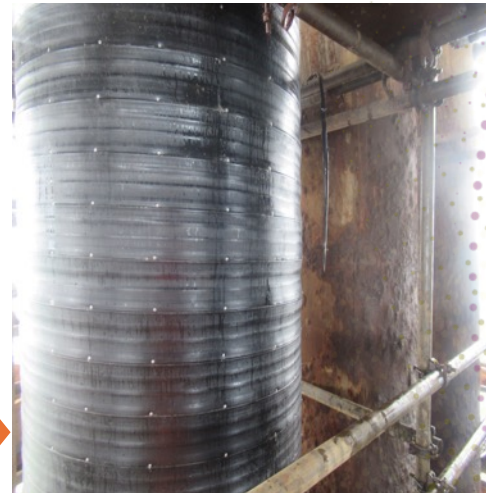
Completed Installation

- MTSB successfully executed the conductor repair activity using Helicoid Epoxy Sleeve system at splash zone which provides cost effective and efficient solution to the client and will help the client to avoid further corrosion build up that may cause pinholes and thereafter parted of the casing.
